ZIEGELBAUER SEPTIC SERVICE LLC

Here is a list of things that need addressing for the septic system located on the property at: 310 North Turtle Bay Road, Elkhart Lake, WI 53020;

Private Onsite Wastewater Treatment System Evaluation

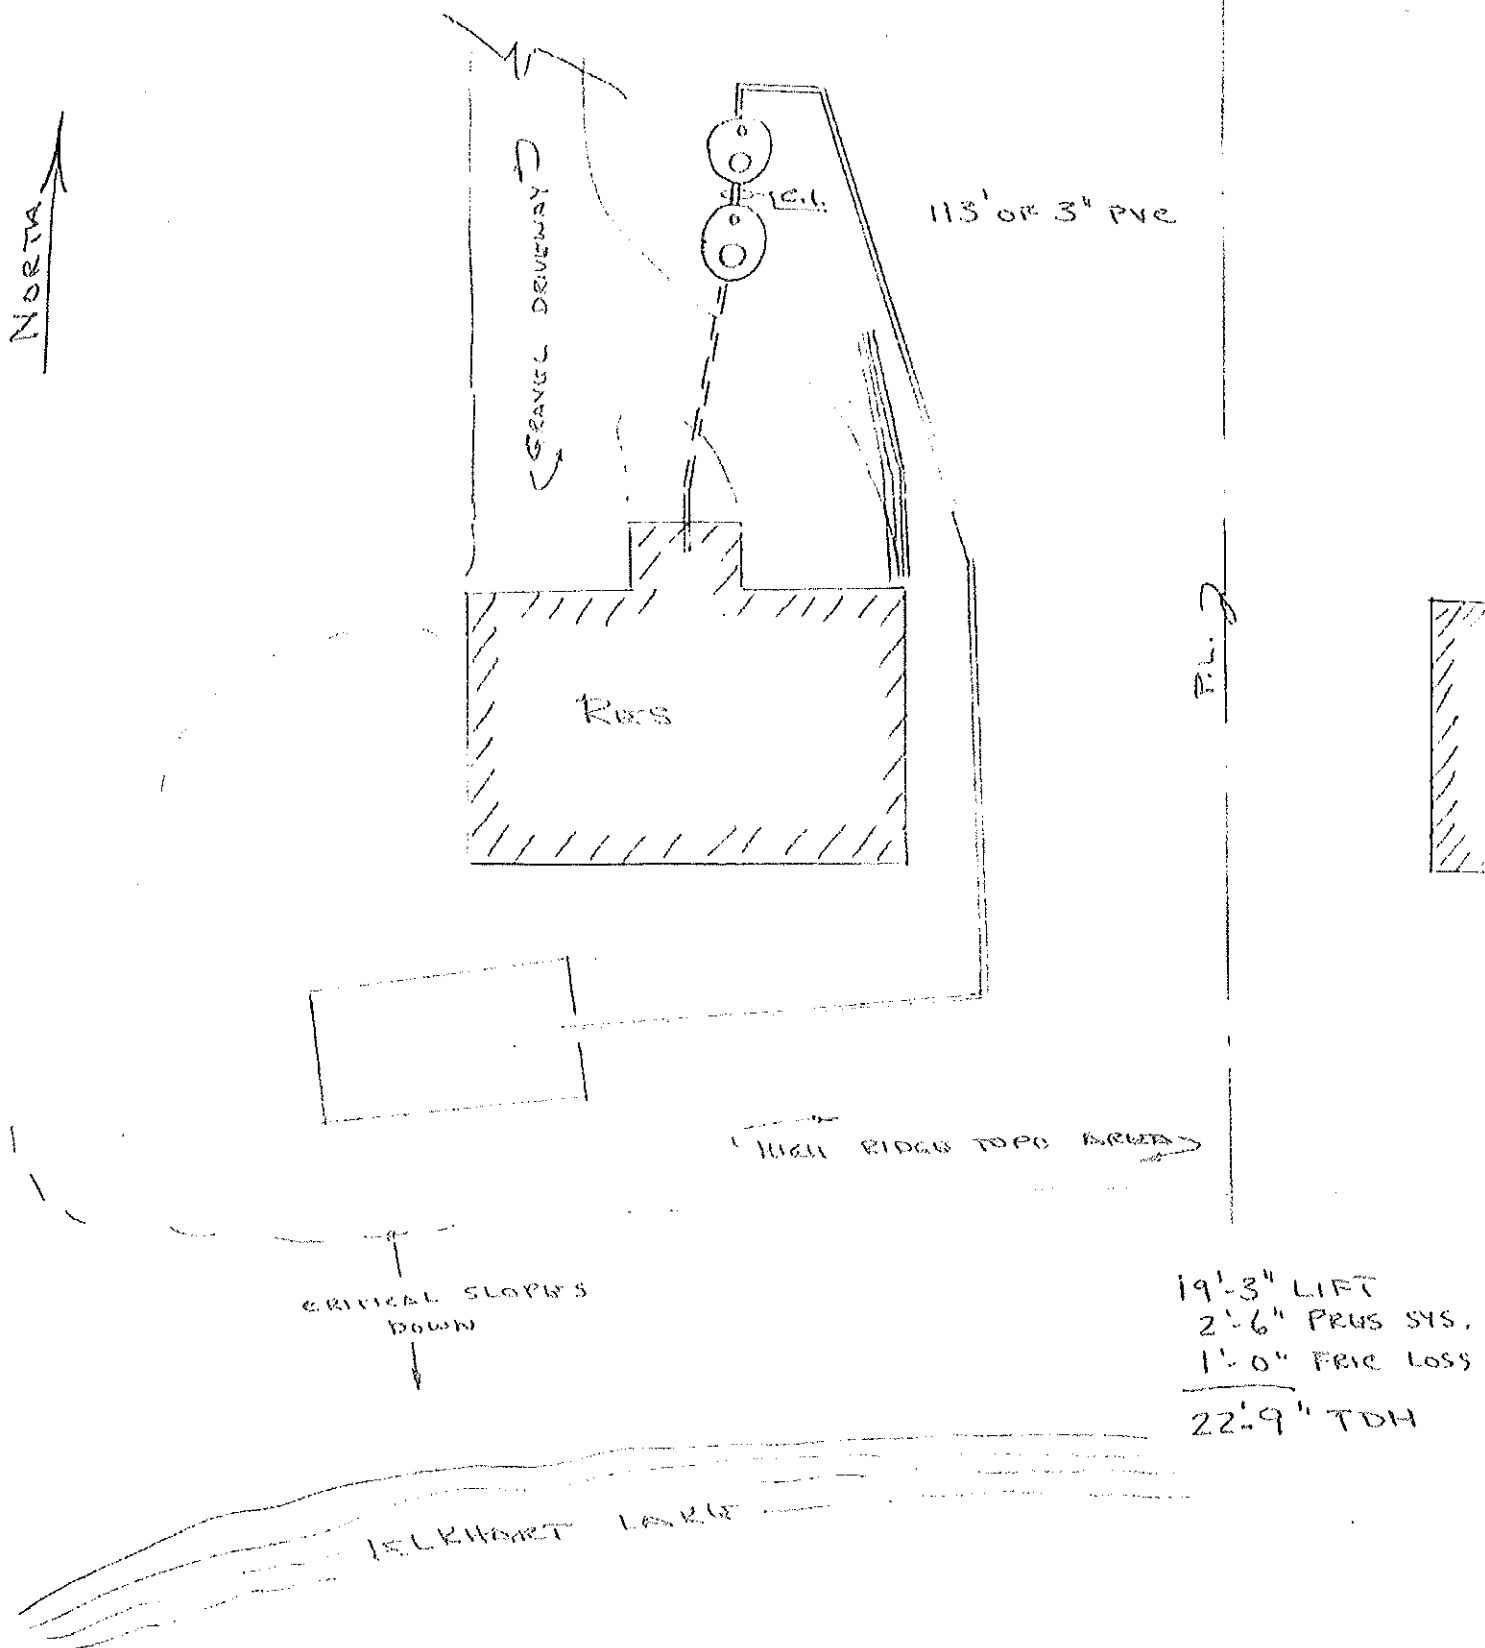
NOTE: Installed near pump
Zoeller 163 automatic
5/29/96

19'-3" LIFT
2'-6" PVE'S SYS.
1'-0" FRIE LOSS

22'-9" TDH
