# Home Inspection Report

N5317 Meadowlark Road, Sheboygan Falls, WI 53085

**Inspection Date:**

Wednesday, June 19, 2024

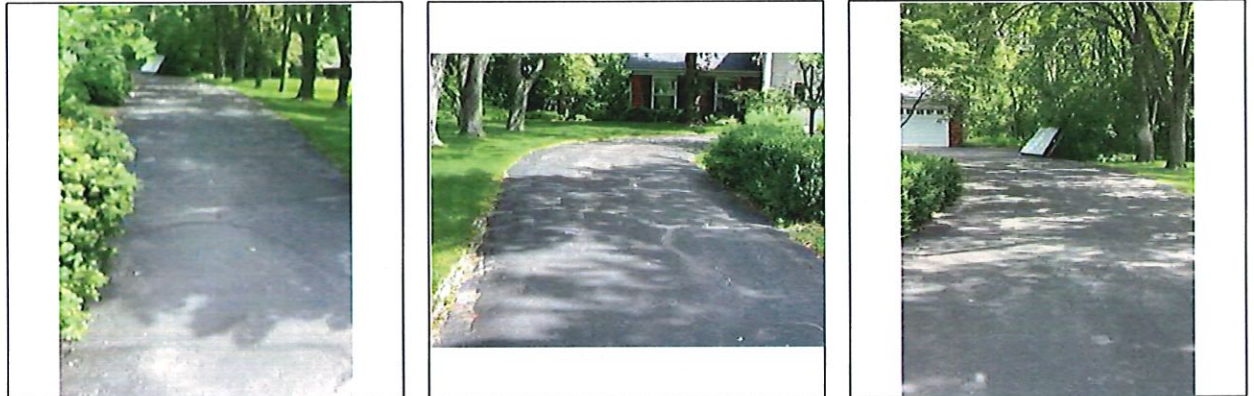
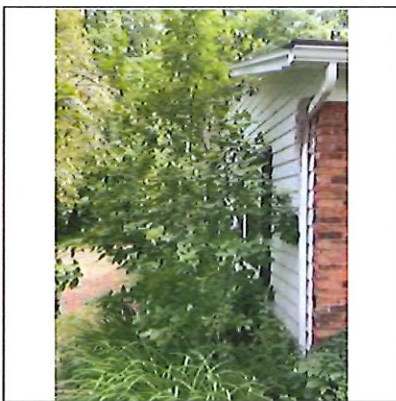
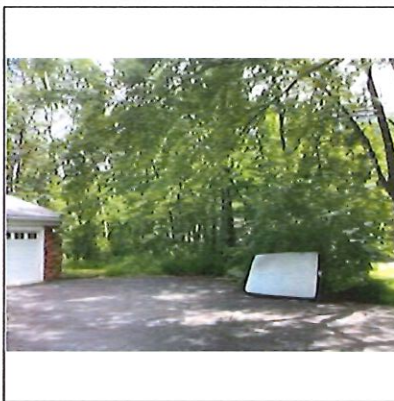
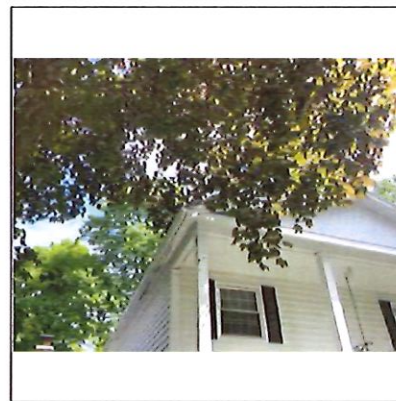
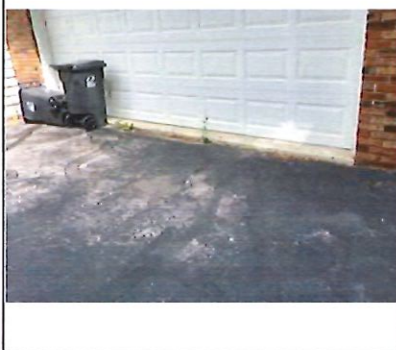
GROUNDS-suggest trimming trees over driveway & next to house-

GROUNDS-driveway settled garage floor trip hazard-

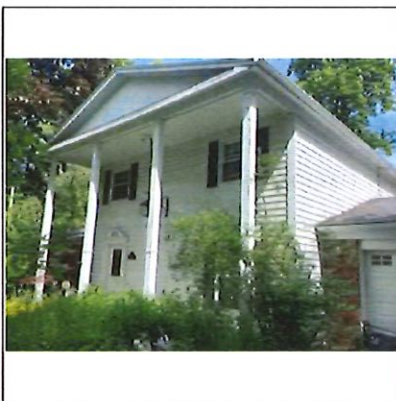
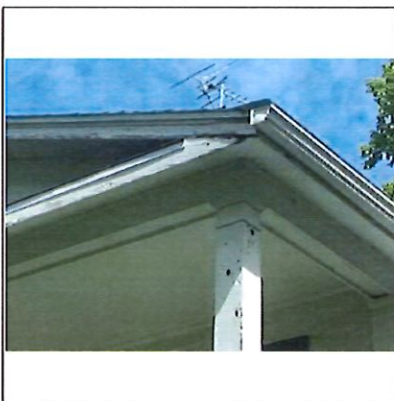
None  Not Visible  
**Condition**  Satisfactory  **Marginal**  Poor  Railing/Balusters recommended  
**Support Pier**  Concrete  Wood Other:   
**Floor**  **Satisfactory**  Marginal  Poor  Safety Hazard  
**Comments** Damaged wood animal, activity-  
**Photos**

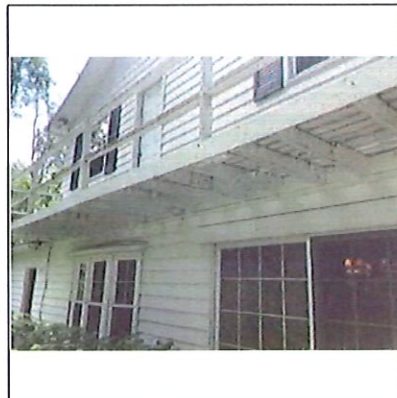
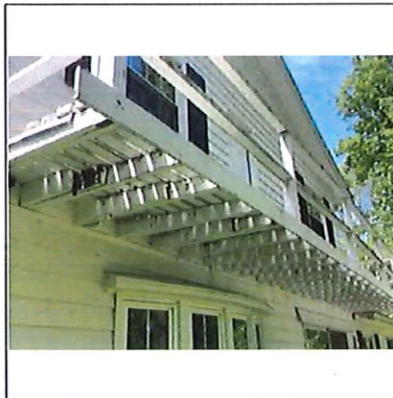
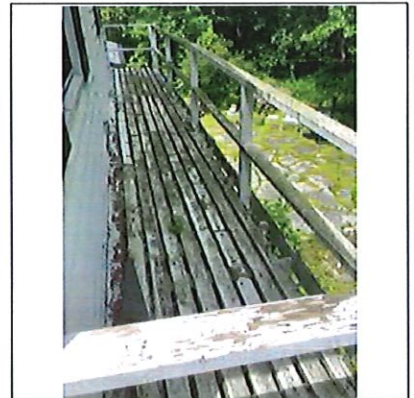
- None  Not Visible
  - Wood  Metal  Composite  Railing/Balusters recommended
  - Satisfactory  Marginal  Poor  Wood in contact with soil
  - Treated  Painted/Stained Other:  Safety Hazard  Improper attachment to house
  - Railing loose  Not Applicable
- Comments  
Photos
- GROUPS-suggest further evaluation wood balcony with proper balusters-

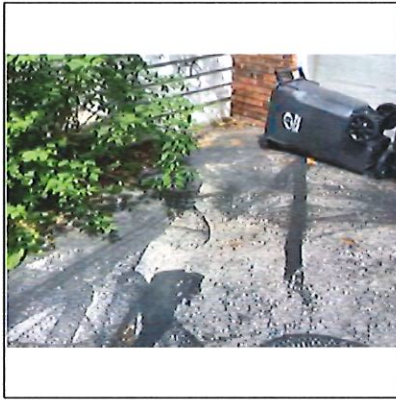
N/A  
**Negative Grade**  East  West  North  South  Satisfactory  Recommend additional backfill  
 Recommend window wells/covers  Trim back trees/shrubberies  
 Wood in contact with/improper clearance to soil  
**Comments** GROUNDS-suggest adding fill left side of garage next to foundation-  
**Photos**

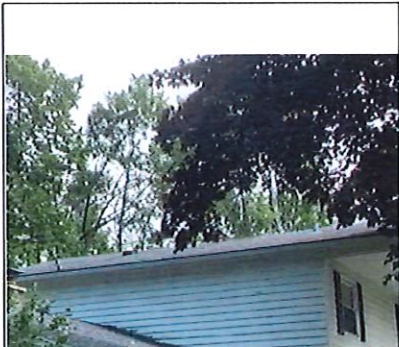
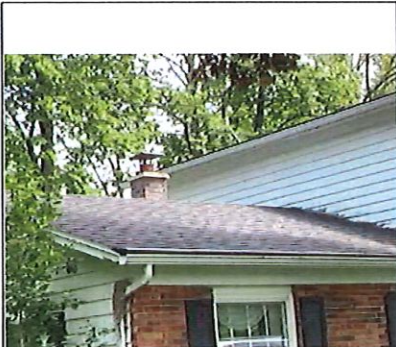
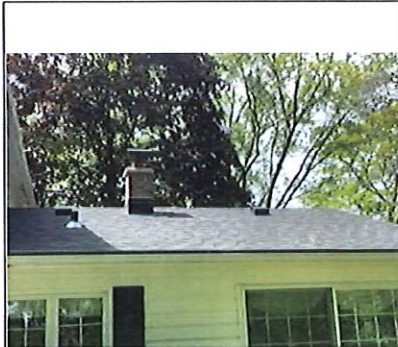
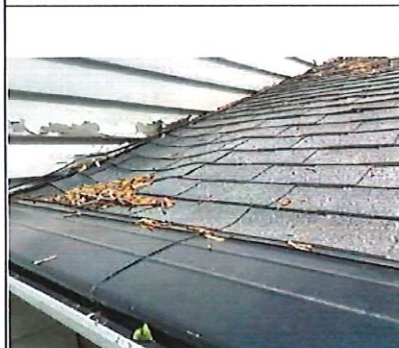
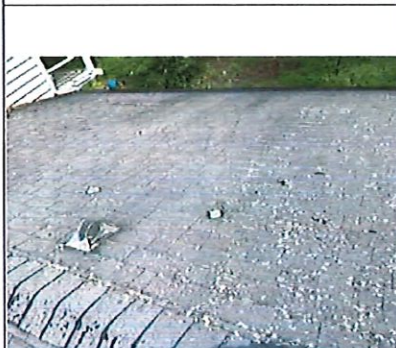
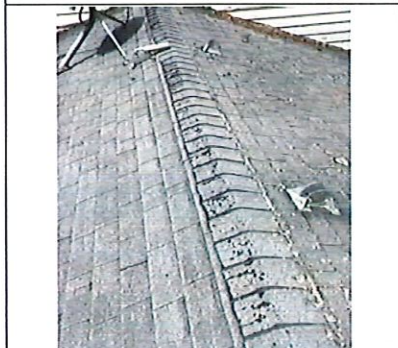
ROOF-Roof covering showed signs of curling, cracking and aging, recommend a qualified roofing contractor evaluate-

Comments ROOF-Roof covering showed signs of curling, cracking and aging, recommend a qualified roofing contractor evaluate-

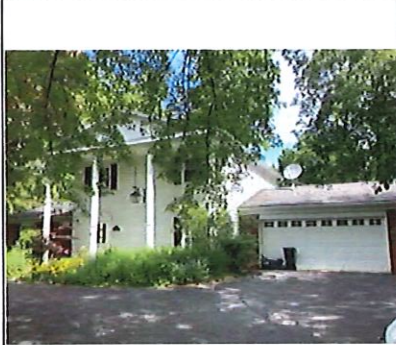
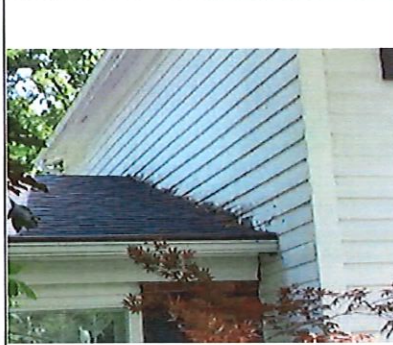
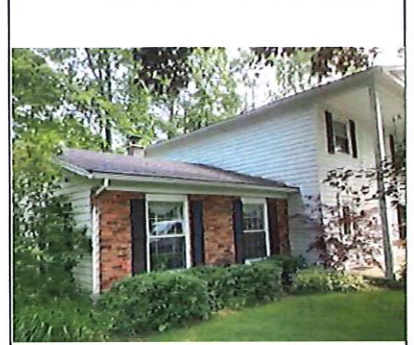
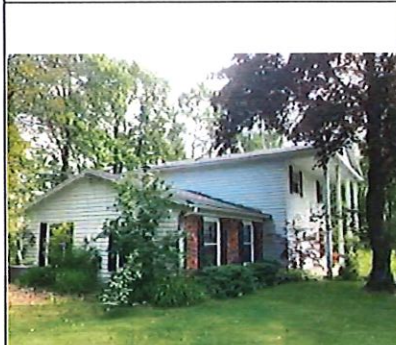
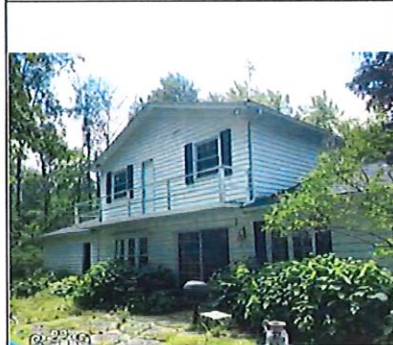
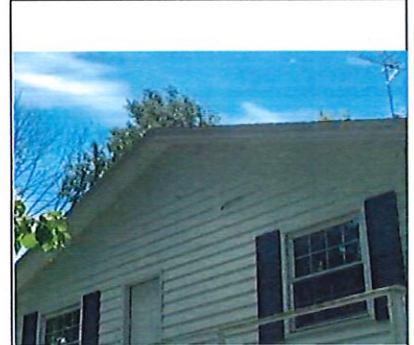
**Condition**  Satisfactory  Marginal  Poor  Recommend repair/painting  
**Comments** Siding had some damage, recommend repairing/replacing damaged sections  
**Photos**

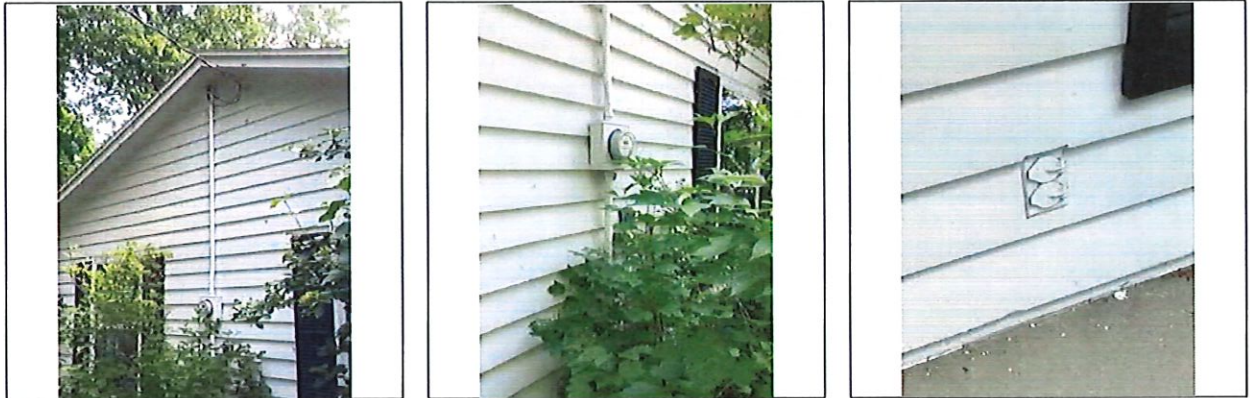
Location  Underground  Overhead  
 Condition  Satisfactory  Marginal  Poor  Weather head/mast needs repair  Overhead wires too low  
 Exterior receptacles  Yes  No Operable:  Yes  No Condition:  Satisfactory  Marginal  Poor  
 GFCI present  Yes  No Operable:  Yes  No  Safety Hazard  Reverse polarity  Open ground(s)  
 Recommend GFCI Receptacles  
 Comments EXTERIOR-suggest GFCI exterior outlets-

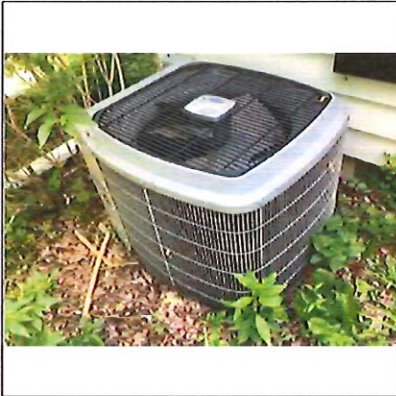
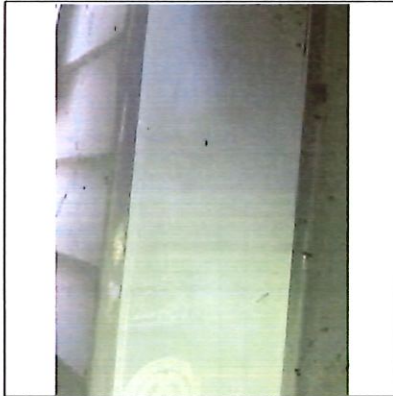
Condition  Satisfactory  Marginal  Poor  Cabinet/housing rusted  
Energy source  Electric  Gas Other:  
Unit type  Air cooled  Water cooled  Geothermal  Heat pump  
Outside Disconnect  Yes  No Maximum fuse/breaker rating (amps): Fuses/Breakers installed (amps):  
 Improperly sized fuses/breakers  
Level  Yes  No  Recommend re-level unit  
Condenser Fins  Damaged  Need cleaning  Damaged base/pad  Damaged Refrigerant Line  Satisfactory  
Insulation  Yes  No  Replace  
Improper Clearance (air flow)  Yes  No  
Comments Suggest servicing AC unit-

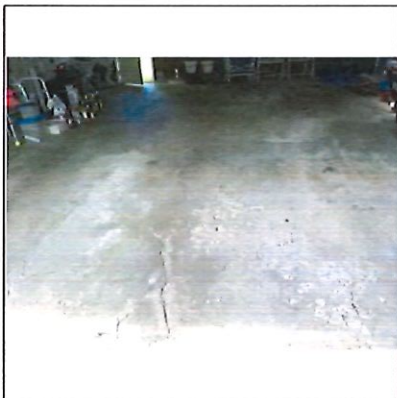
GROUNDS-driveway settled garage floor trip hazard-

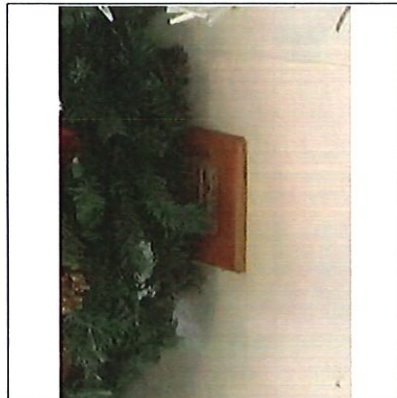
Comments GARAGE-suggest GFCI outlets-

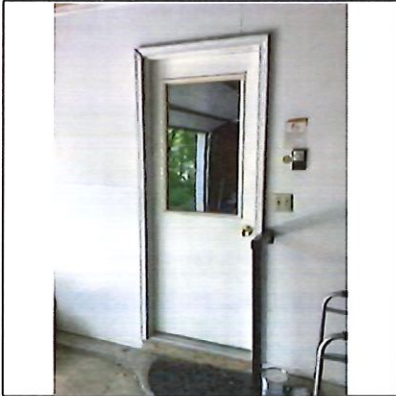
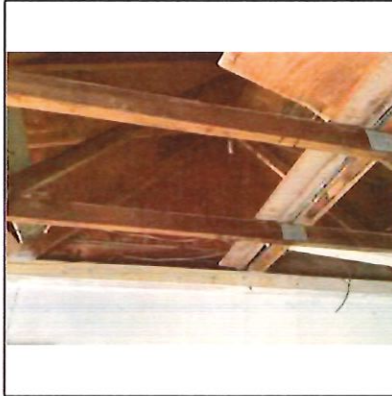
Comments GARAGE-suggest proper fire rats door no window to house & drywall to the peak-
