# **HOMEWRX INSPECTIONS**

RESIDENTIAL REPORT

1712 S 12th St Sheboygan, WI 53081

08/13/2024

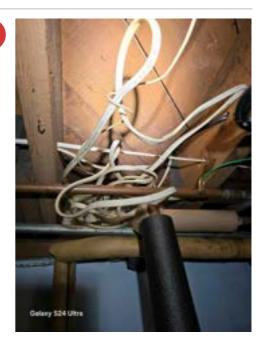
#### **HANDYMAN WIRING**

Handyman wiring describes any wiring that does not appear professionally installed by a qualified electrician. Some examples of handyman wiring include: Extension cord wiring in place of permanent wiring, exposed wires run below ceiling joists and not in conduit, wires spliced outside of junction boxes, etc. Recommend evaluation/repair(s) by qualified electrician.

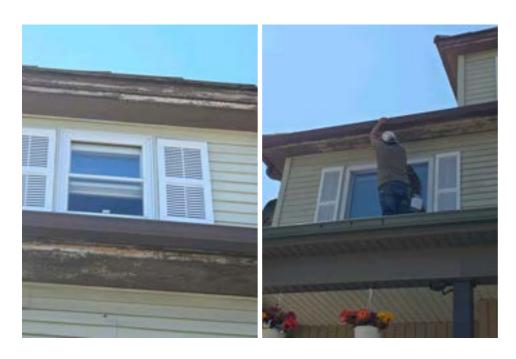
3.11.1 Soffit

# PEELING PAINT AT EXTERIOR WOODEN SOFFIT/FACIA. (PAINTING IN PROGRESS AT TIME OF INSPECTION)

Recommend ensuring completion of project by qualified contractor and recommend obtaining any paperwork/lien waiver information.

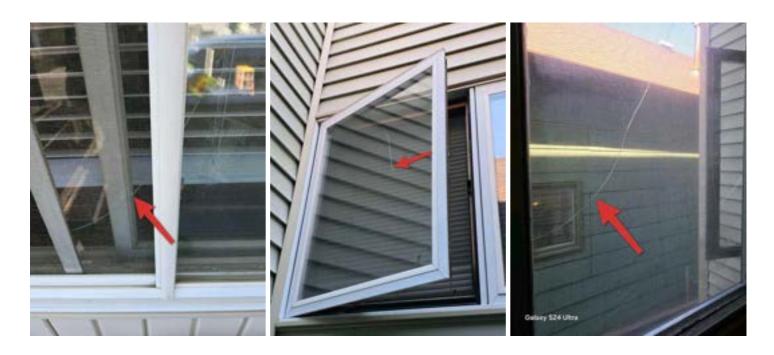
3.16.1 Windows

# CRACKED GLASS OBSERVED AT BASEMENT WINDOW(S)

Cracked glass observed at basement window(s). Recommend evaluation/repair by qualified contractor.

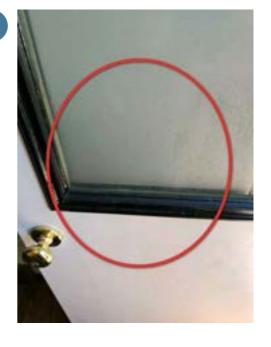
3.17.1 Exterior Doors

#### Repair/Evaluate/Maintenance/Monitor **FOGGED WINDOW** PANE(S) OBSERVED AT EXTERIOR DOOR(S)

**REAR DOOR**

Fogged window pane(s) in door. Recommend evaluation/repair by qualified contractor.

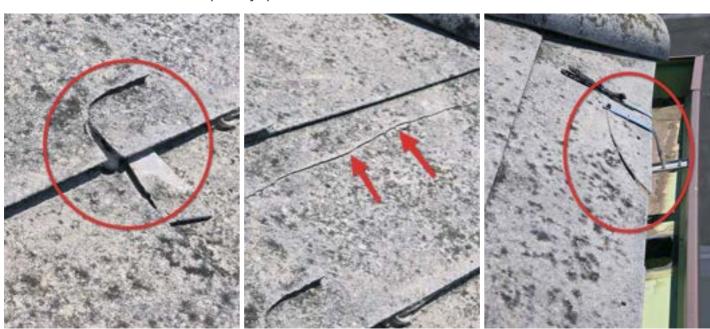
## CRACKS OBSERVED AT SLATE SHINGLES. (SOME AREAS OF ROOF NOT **VISIBLE FOR INSPECTION)**

Recommend evaluation and repair by qualified contractor

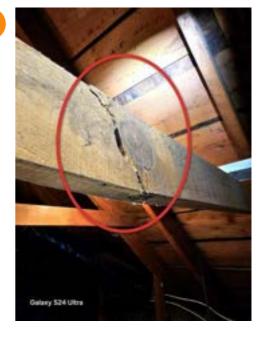
# CRACKED CROSS MEMBER OBSERVED IN ATTIC

Recommend evaluation and repair by qualified contractor

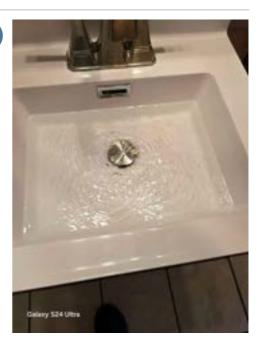
#### SECOND FLOOR **BATHEOOM SINK DRAINED SLOWLY**

Sink drained slowly. Recommend evaluation/repair by qualified plumber.

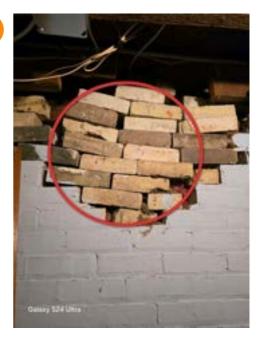
23.1.1 Foundation Walls

# LOOSE BRICKS/DAMAGED AREA OBSERVED AT FOUNDATION WALL

Recommend evaluation and repair by qualified contractor

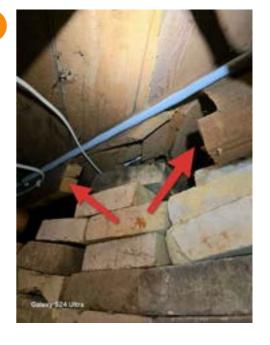
23.2.1 Support Structure

## MODIFIED/DAMAGED FLOOR JOIST(S) OBSERVED

Recommend evaluation and repair by qualified contractor

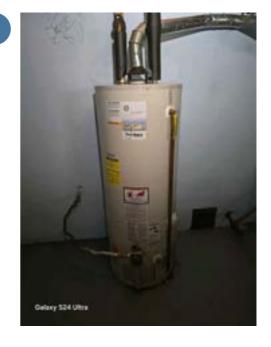
#### Repair/Evaluate/Maintenance/Monitor MONITOR/BUDGET ITEM - WATER HEATER IS NEARING OR BEYOND **NORMAL LIFE EXPECTANCY**

MANUFACTURED IN 2008

The water heater is nearing (within 5 years of) or beyond normal life expectancy (based on 10-year average life expectancy). Recommend monitoring the water heater and recommend budgeting for repairs or replacement at any time.

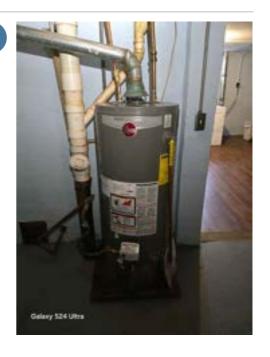
Homewrx Inspections Page 49 of 53 25.2.1 Water Heater 2

### Repair/Evaluate/Maintenance/Monitor MONITOR/BUDGET

MANUFACTURED IN 2014

The water heater is nearing (within 5 years of) or beyond normal life expectancy (based on 10-year average life expectancy). Recommend monitoring the water heater and recommend budgeting for repairs or replacement at any time.
