THIS CONDITION REPORT CONCERNS THE REAL PROPERTY LOCATED AT W6749 Esker Ridge
IN THE Elkhart Lake
(CITY) (VILLAGE) (TOWN) OF Rhine, COUNTY OF
Sheboygan STATE OF WISCONSIN.

March 21, 2013

Re: Goetsch Residence
W6749 Esker Ridge
Elkhart Lake, WI 53020

FUNGAL AND MOISTURE ASSESSMENT

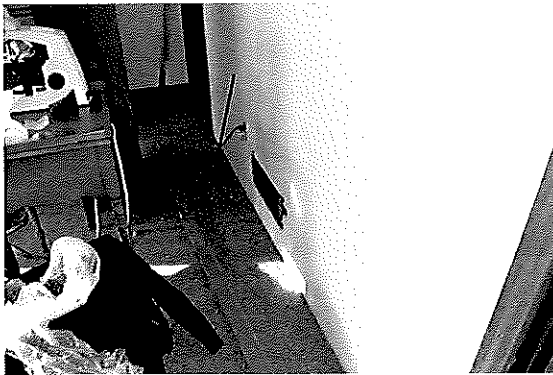
A follow up destructive investigation was conducted on March 21, 2013. The baseboards were removed from the southeastern room and hallway adjoining the mechanical room. The drywall was observed installed to the concrete floor below the carpet level. Normal conditions were observed behind the baseboards on the baseboards, drywall, and carpet. The bathroom door casing was removed and the jamb and drywall assessed and again normal conditions were observed. The bathroom vanity was then removed and inspection holes cut into the closed space between the bathroom and the southeastern room and normal conditions were observed within the wall cavity. An inspection hole was then cut at base level behind the sole plate of the mechanical room and fungal growth was observed on the paper backing. Further assessment of the drywall behind the sole plate observed additional fungal growth and microscopically confirmed to be *Chaetomium sp.*

Removal of Baseboard in Southeast Room

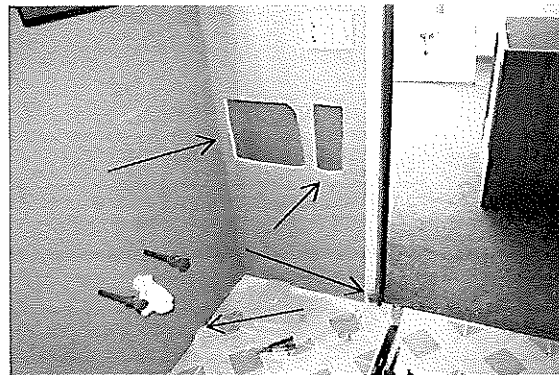
Inspection Holes in Bathroom

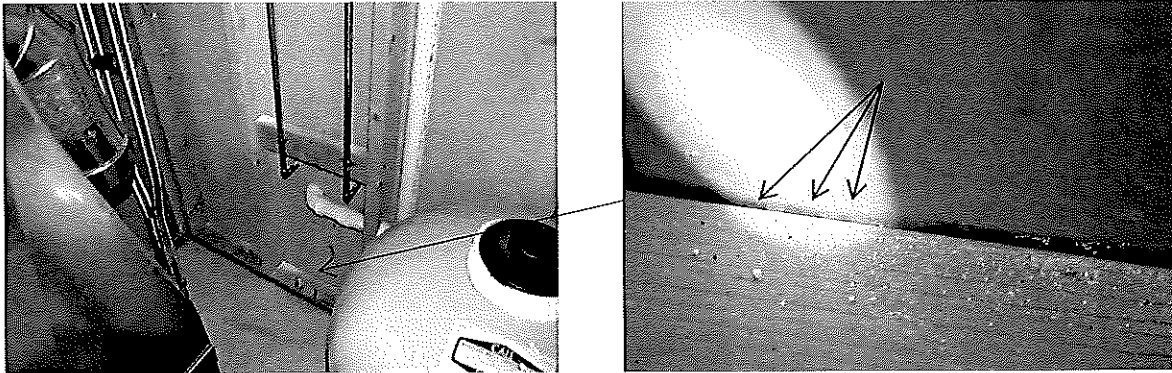
Fungal Growth on Drywall in Mechanical Room Adjoining Bathroom
