**Jim Weyenberg State Lic# 979-106
920-850-5890**

Inspection Report April 17, 2024

Property Address:
N522 34th Dr
Berlin WI 54923

Date: 4/17/2024	Time: 02:00 PM	Report ID: 2404172
Property: N522 34th Dr Berlin WI 54923	Customer: Shannon Sloan	Real Estate Professional: Nikki Kapellen

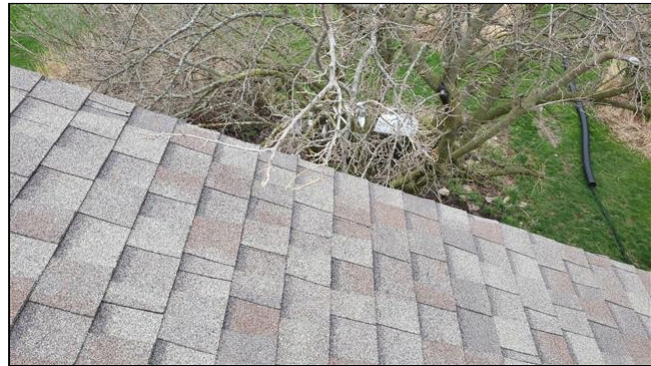
1.0 Item 6(Picture)

(2) The tree limbs that are in contact with roof or hanging near roof should be trimmed.

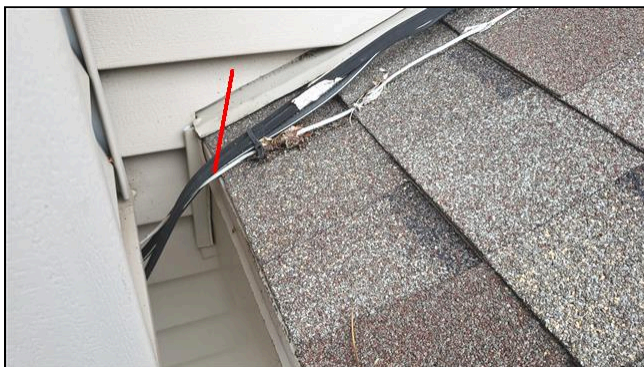
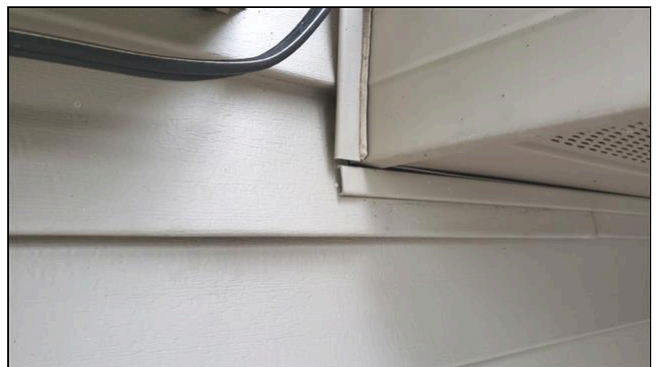
(1) Lacking a kick out flashing at the roofing to siding joint.

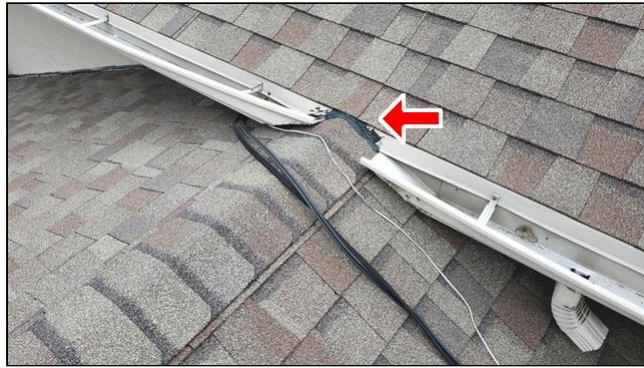
1.1 Item 3(Picture)

(2) Sealant separation apparent.

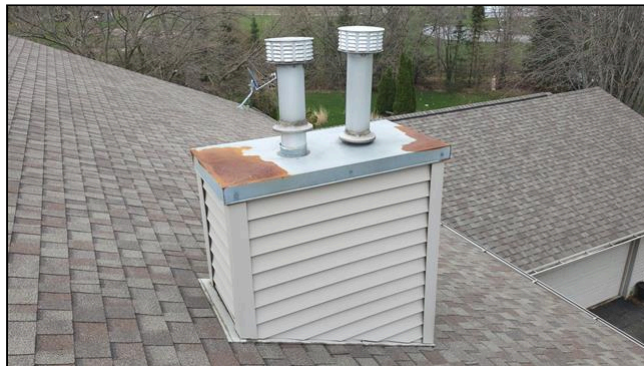
1.2 Item 1(Picture)

(1) Rust on the crown will stain the siding below, suggest applying EndRust then Rustolium To prevent this.

(1) Rust on the crown will stain the siding below, suggest applying EndRust then Rustolium To prevent

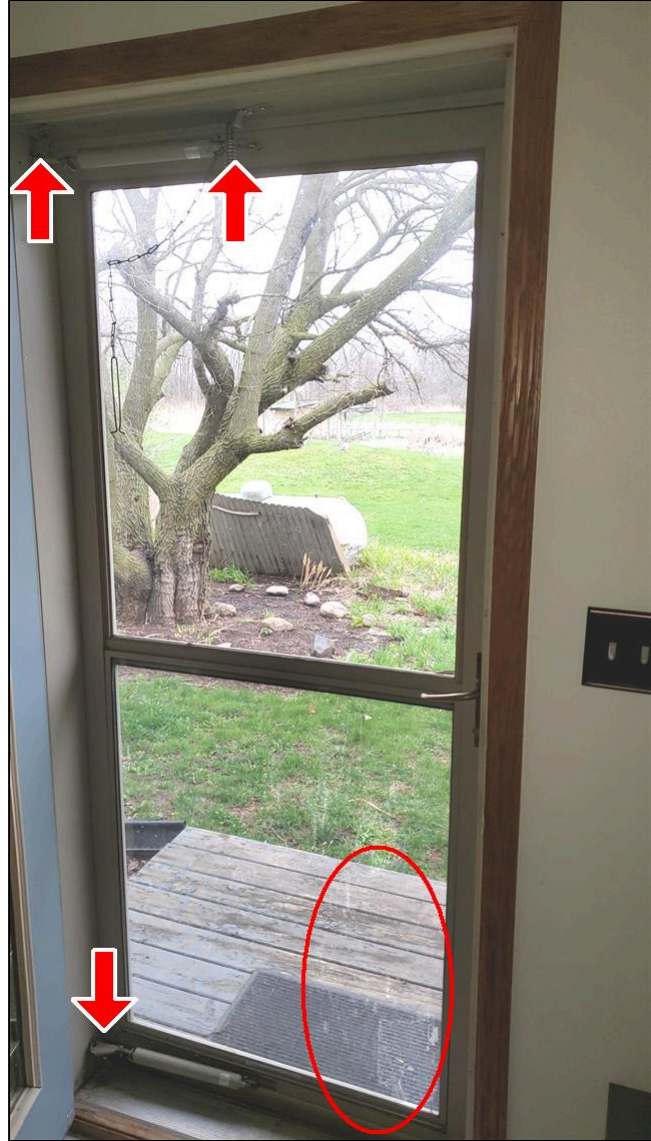
2.1 Item 1(Picture)

(1) Window trim is coming off the front door.

(2) The storm door at the rear needs maintenance.

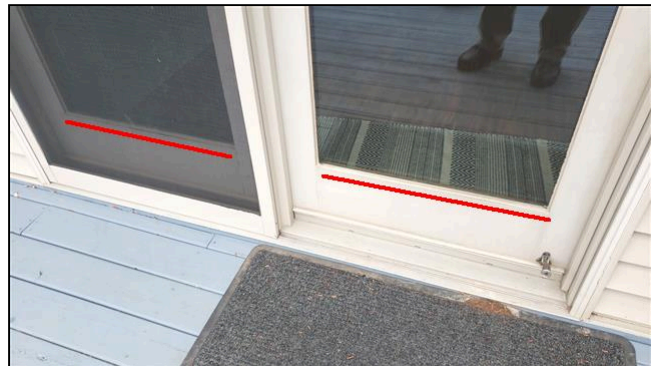
2.1 Item 2(Picture)

(3) Anderson patio doors of this type are prone to delamination at the bottom section due to finish surface deterioration at the horizontal edges.

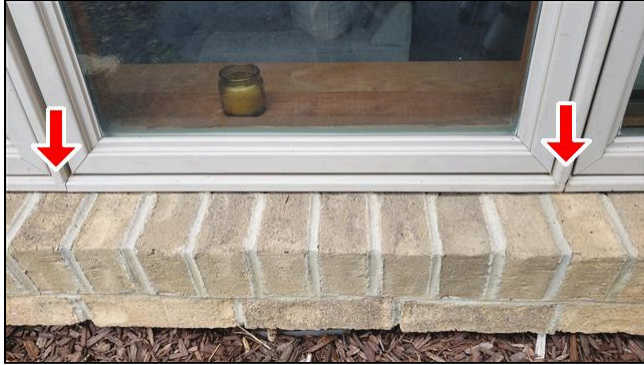
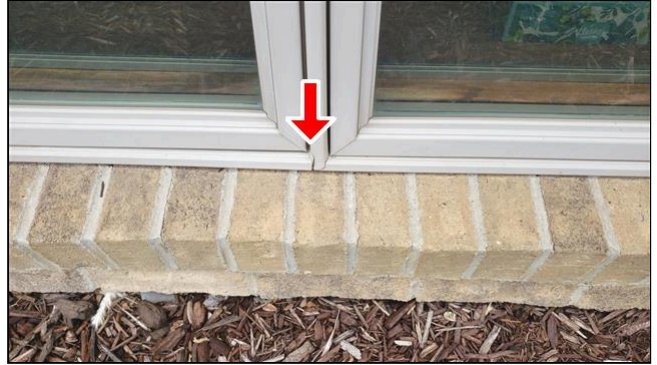
Anderson windows of this type, age and color are prone to cracking at the base of the mullions, they do have a repair kit for this.

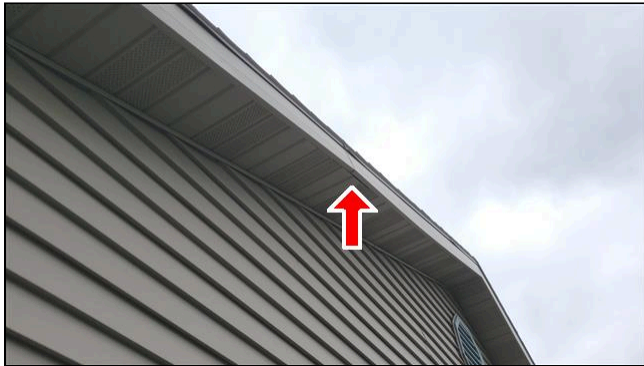
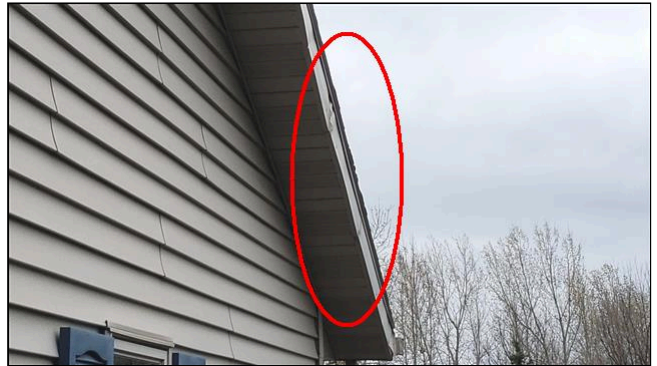
Loose and damaged fascia at the front gable end.

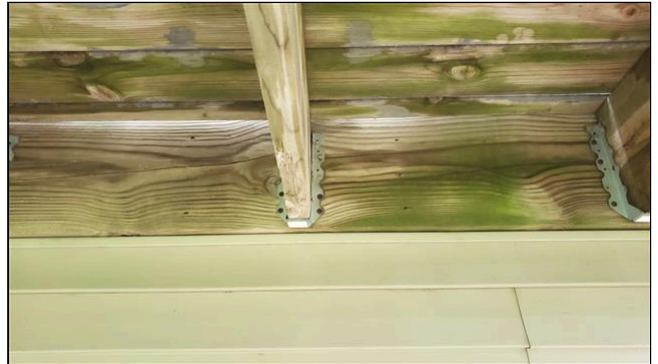
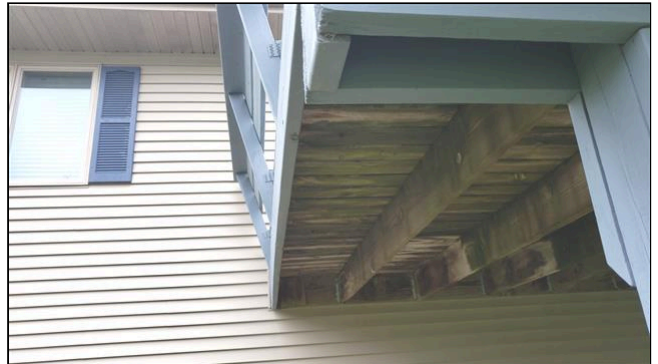
(1) The deck is not up to todays standards.

Lag bolts or screws are required through the ledgerboard into the rim joists.

The deck rim joist should be doubled or blocked together, especially at a railing post.

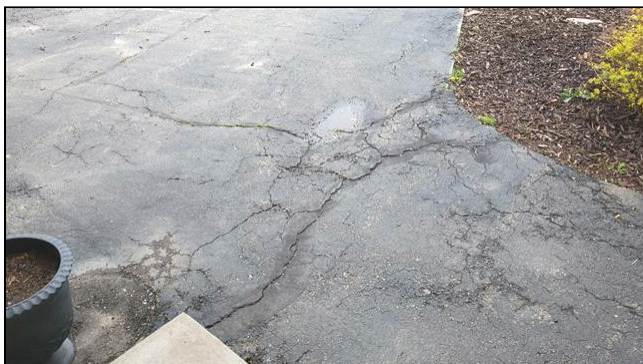
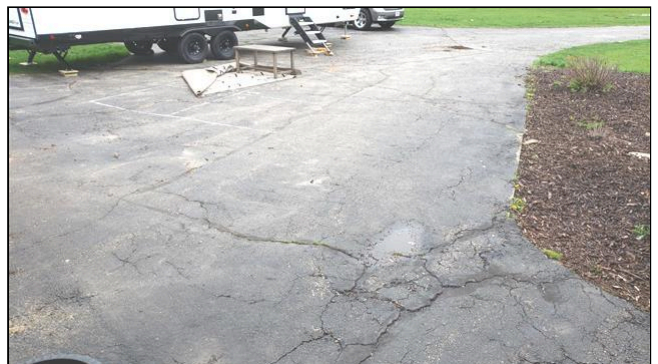
(2) The asphalt driveway and walk way are significantly unmaintained which caused the cracking and heaving in many areas.

Pavement must be kept well sealed to keep water out from under it, that causes frost heave.

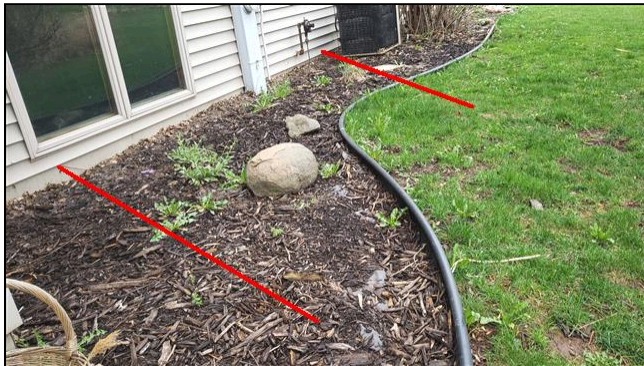
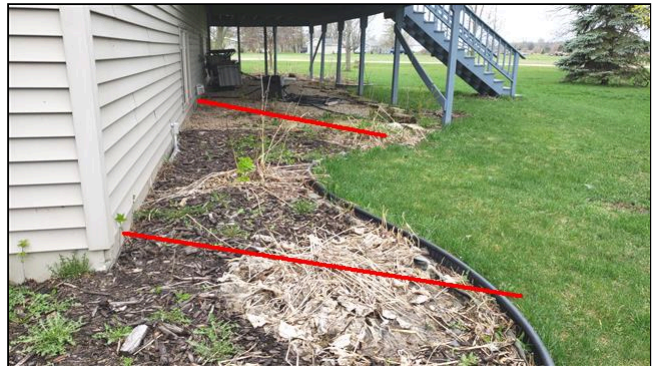
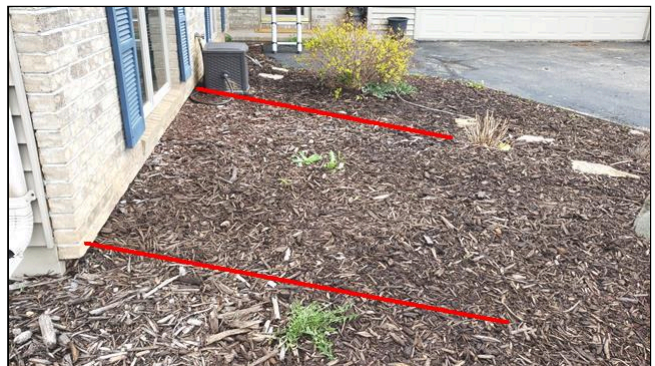
(3) Negative grading at the foundation is apparent in many areas around the foundation. This can cause significant damage to the foundation. The grading at the foundation should slope down and away from the foundation at at least an inch per foot out 4' or better or to a point at which the water can keep flowing away. Best practice is to then cover the dirt with heavy mil plastic sheeting tucked up under the siding starter strip, then some sort of landscape material, fist size (3") round river rock works best. THEN NO EDGING!

With that done, after one good dry summer, the back fill will dry so much that it will shrink and take pressure off the foundation wall and stop any moisture from permeating through the wall, drying off into the bsmt as water vapor, that would have to be removed by a dehumidifier.

Grading at the foundation should be looked at as a preservation related improvement to protect the foundation.

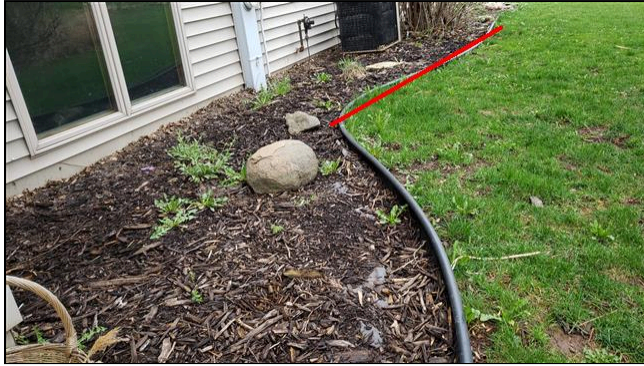
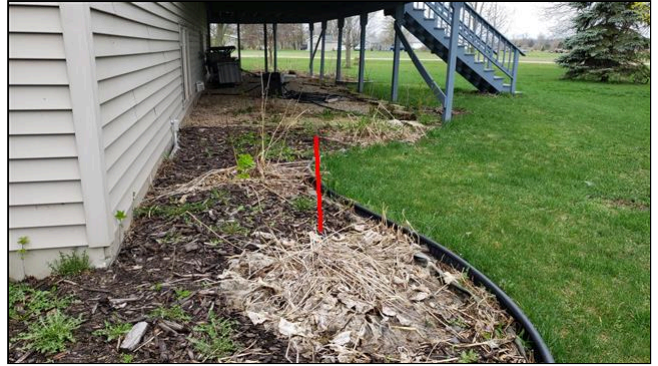
Edging of any depth to close to the foundation will actually act as a dam holding water from draining away from the foundation. Water needs to flow quickly well away from the foundation.

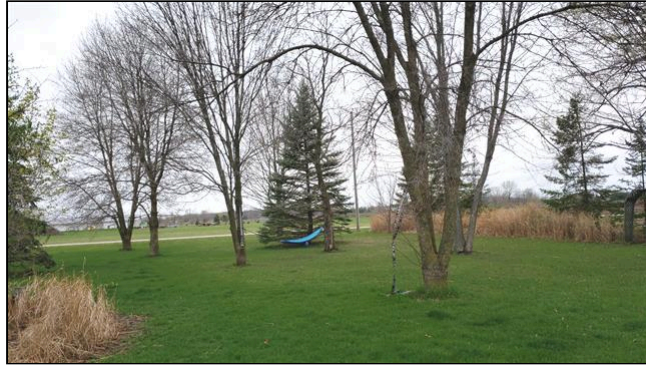
2.9 Item 1(Picture)

(1) There are a number of ash trees on the property that are affected by the emerald ash borer.

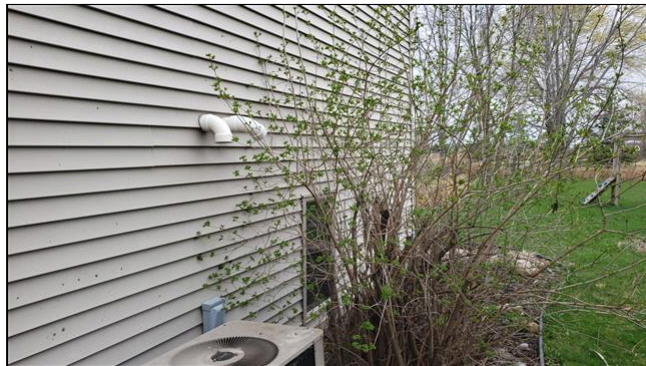
2.9 Item 2(Picture)

(2) Shrubs contacting the siding.

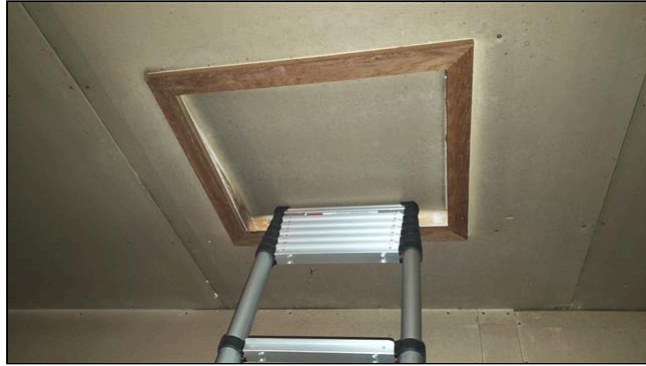
3.4 Item 1(Picture)

The fire separation on the garage ceiling is compromised by the wood trim holding up the hatch cover, suggest placing 2" drywall strips vertically around the access tunnel to complete the fire separation. Then add wire hold downs so fire pressures can't lift the cover.

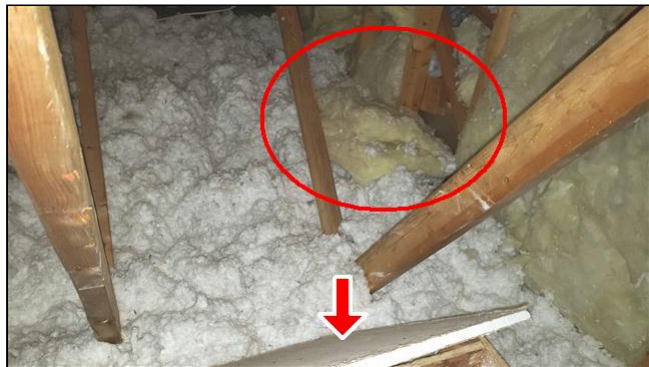
4.0 Item 9(Picture)

(2) Batt insulation falling off the vertical wall I was able to replace and it's holding.

Missing insulation on the access cover at the south attic access.

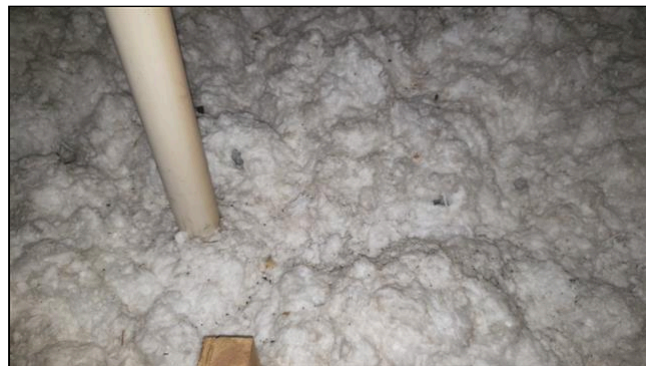
4.7 Item 1(Picture)

Mouse tunnels and trails apparent in the insulation. However no feces were apparent, this indicates a past occurrence and not an ongoing thing.

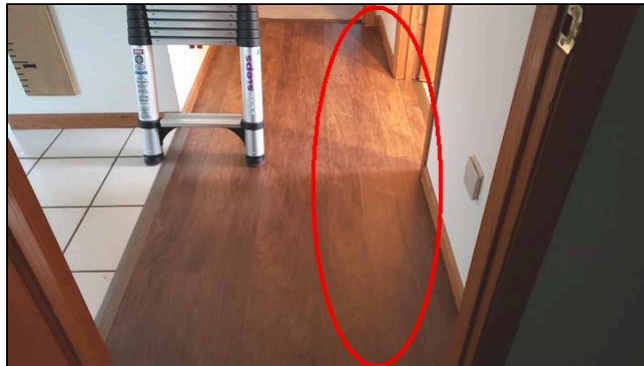
5.3 Item 1(Picture)

This points to the wall possibly not directly over a floor truss.

Could not see this area due to the finished ceiling in the lower level.

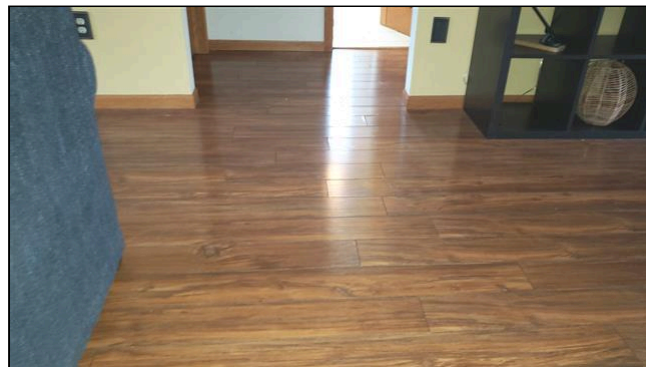
7.2 Item 1(Picture)

(1) The laminate flooring in the upper shows delamination occurring in many areas.

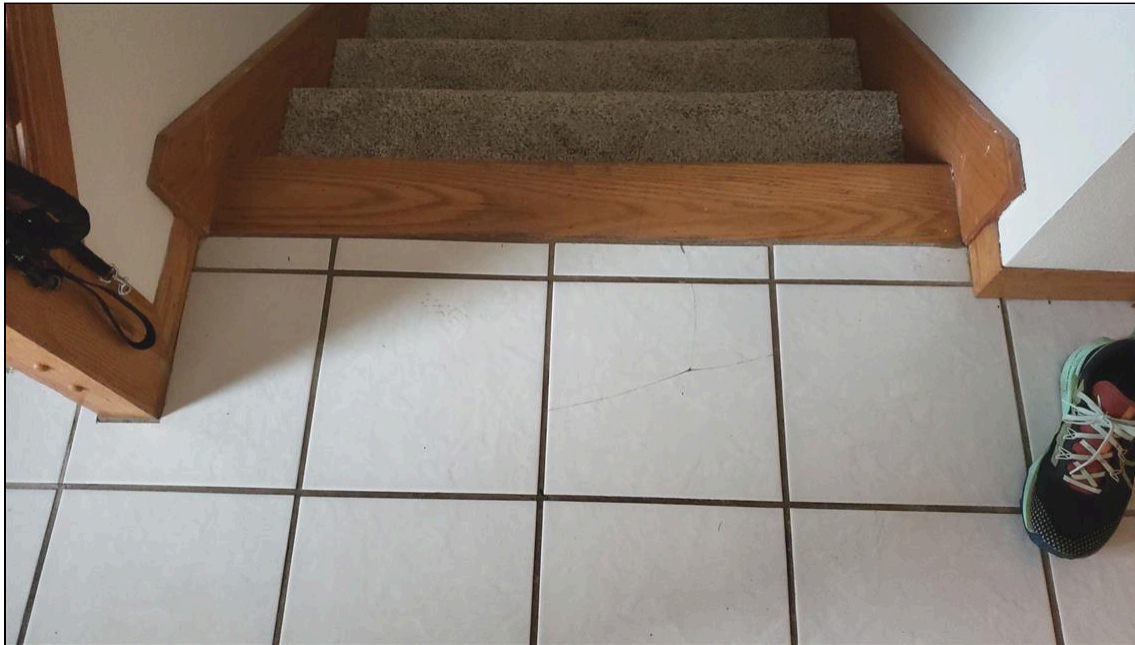
7.2 Item 2(Picture)

(2) Cracked tiles apparent in the kitchen.

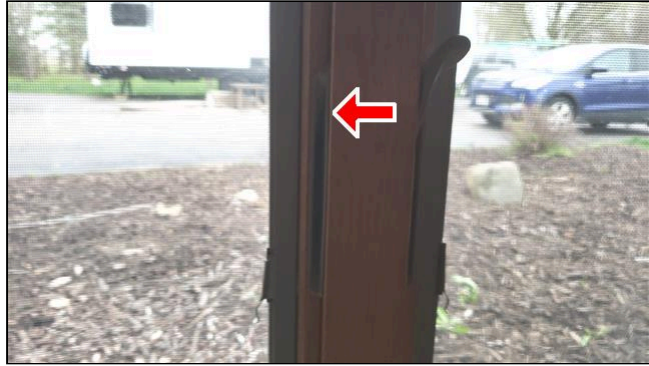
7.6 Item 1(Picture)

Missing window latch at the lower east

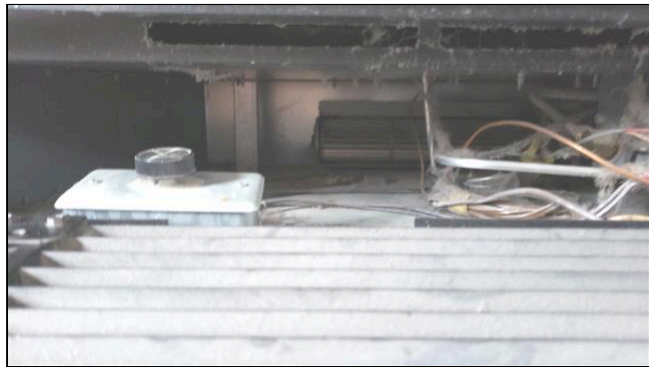
7.8 Item 1(Picture)

Mouse feces under the fireplace.

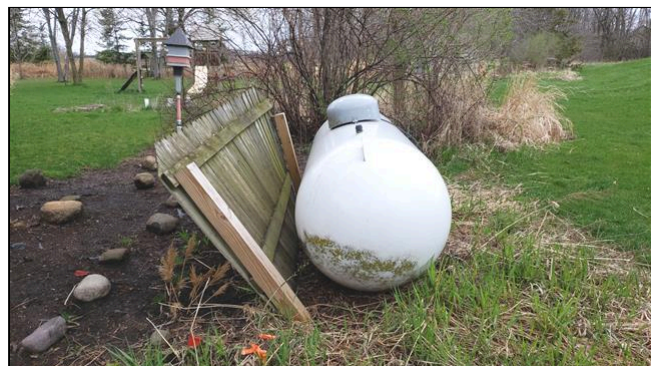
8.4 Item 1(Picture)

The LP tank is leaning over significantly.

This may be caused by the low wet saturated soil under it.

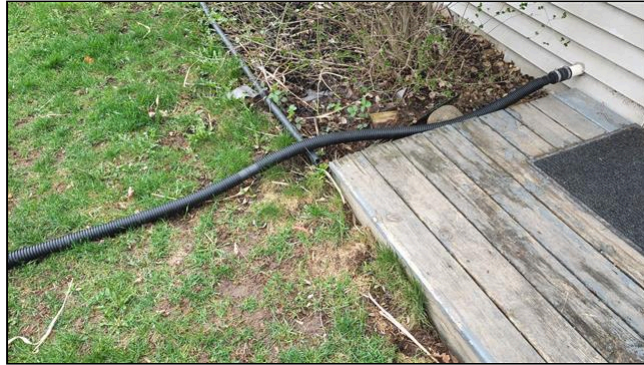
8.6 Item 1(Picture)

Flex piping is not recommended in our climate.

Suggest changing to ABS black plastic discharge piping with an air gap at the exterior to prevent siphoning.

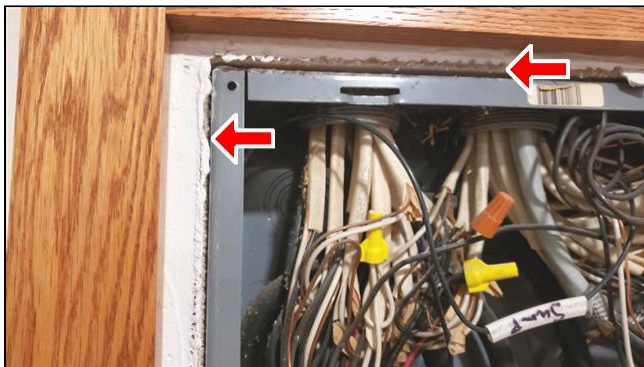
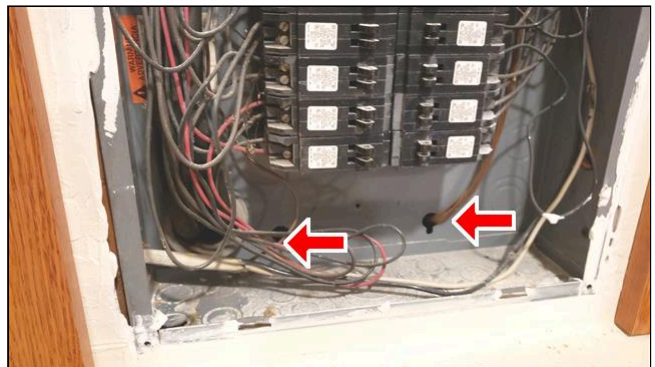
(1) The panel cover does not fit tight to the box as it is designed to. This can allow arc flash to access combustible materials in the wall. Suggest removing the screws in the sides of the box to pull it out enough to protrude from the drywall so the cover fits tight to the box.

Also knock outs in the box should be sealed.

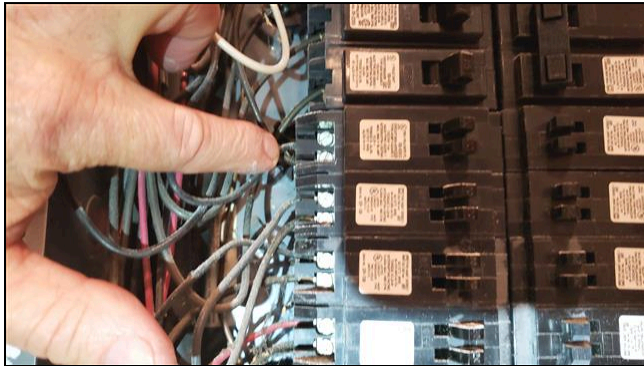
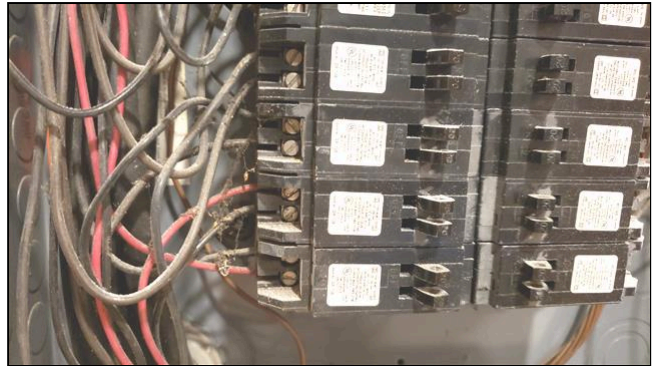
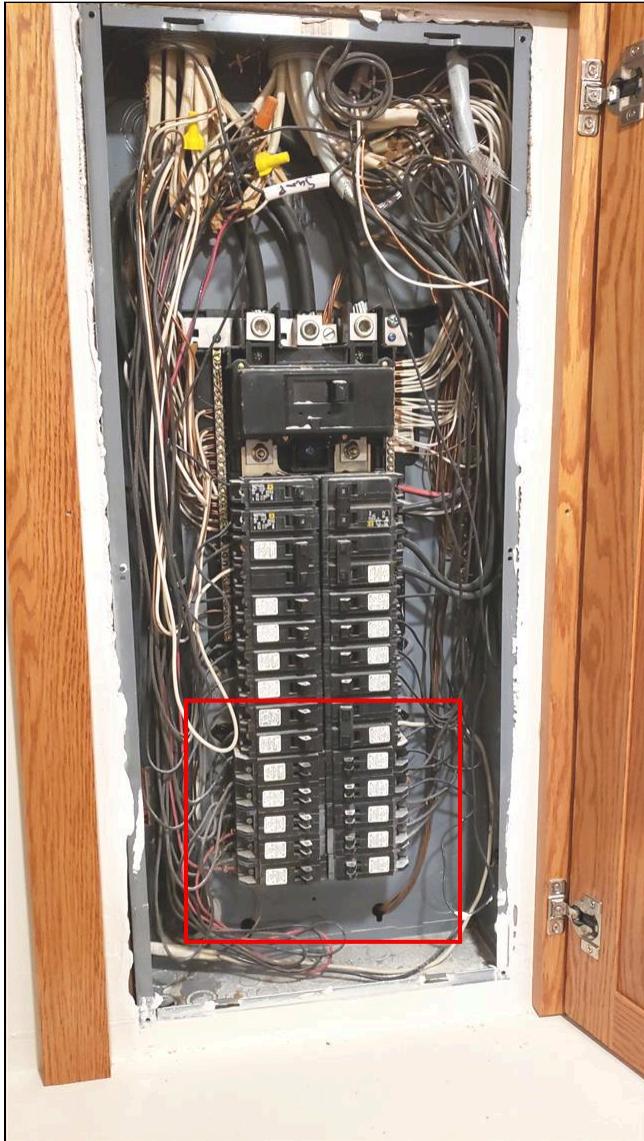
⚡ Multiple 14 GA conductors on 20 amp breakers poses a fire hazard. Change the breakers out to 15 amp.

This points to less than professional work.

Multiple 14 GA conductors on 20 amp breakers poses a fire hazard. Change the breakers out to 15 amp.

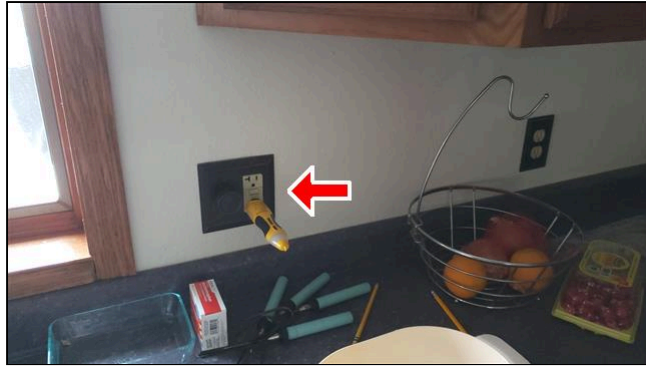
9.3 Item 1(Picture)

⚡ (1) Faulty GFCI receptacle at the west side of the kitchen.

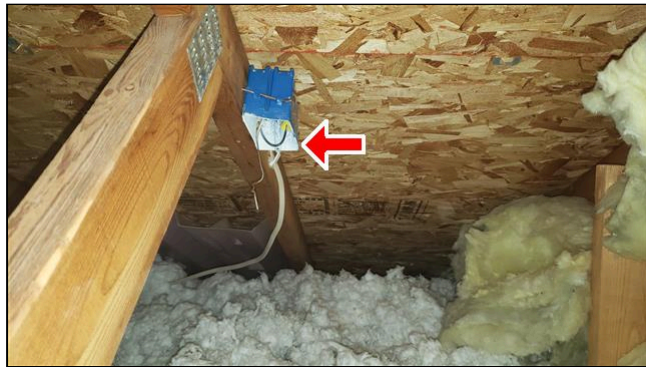
9.3 Item 2(Picture)

⚡ (2) Missing junction box cover in the south attic.

(2) Missing junction box cover in the south attic.

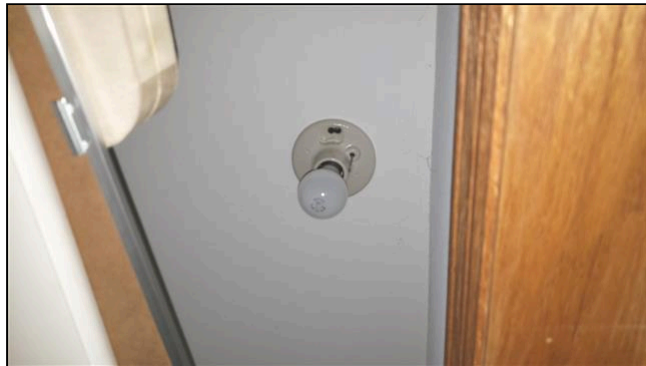
9.3 Item 3(Picture)

⚡ (3) Incandescent bulbs in a closet pose a fire safety concern.

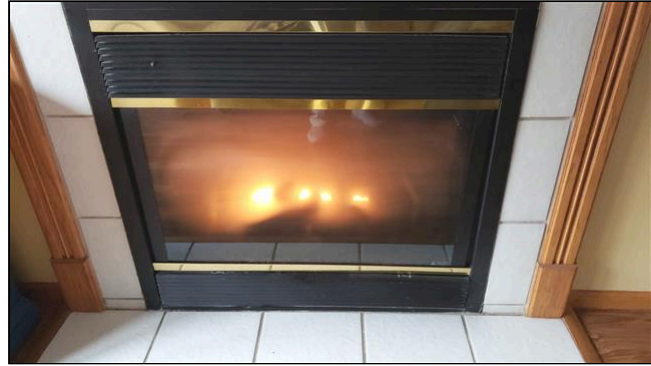
10.5 Item 1(Picture)

(1) The LP fireplace has not seen maintenance for some time.

(2) For Gas fireplace Repair and tune up, call Les Kasten 920-585-4442
