# Home Inspection Report

N5317 Meadowlark Road, Sheboygan Falls, WI 53085

**Inspection Date:**

Wednesday, June 19, 2024

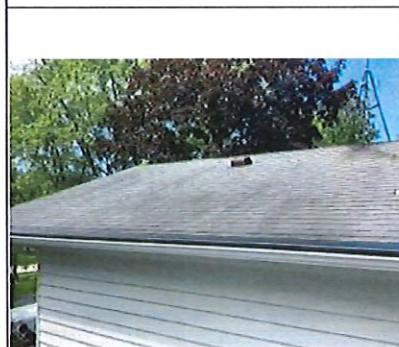
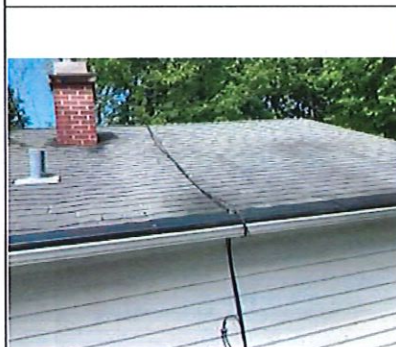
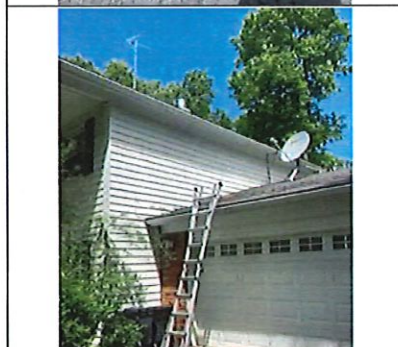
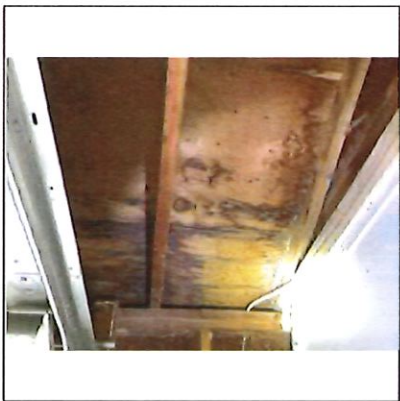
Comments ROOF-Roof covering showed signs of curling, cracking and aging, recommend a qualified roofing contractor evaluate-

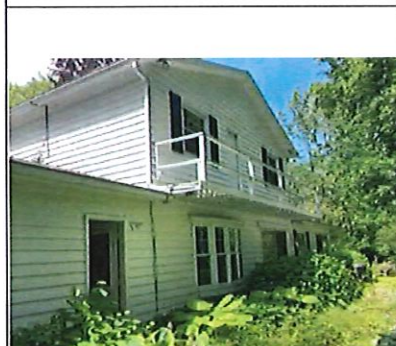
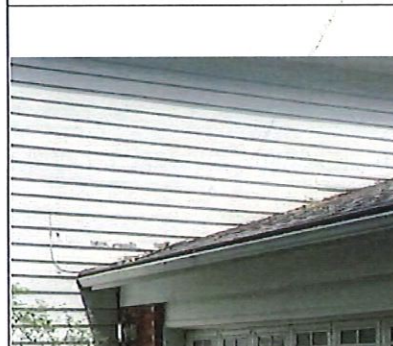
**Condition**  Satisfactory  Marginal  Poor  Recommend repair/painting  
**Comments** Siding had some damage, recommend repairing/replacing damaged sections  
**Photos**
