**Jim Weyenberg State Lic# 979-106
920-850-5890**

Inspection Report April 17, 2024

Property Address:
N522 34th Dr
Berlin WI 54923

Date: 4/17/2024	Time: 02:00 PM	Report ID: 2404172
Property: N522 34th Dr Berlin WI 54923	Customer: Shannon Sloan	Real Estate Professional: Nikki Kapellen

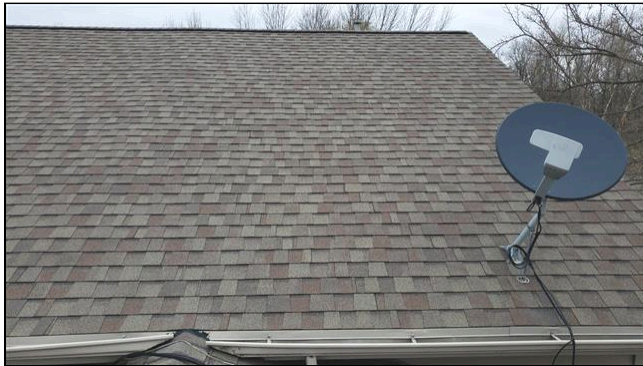
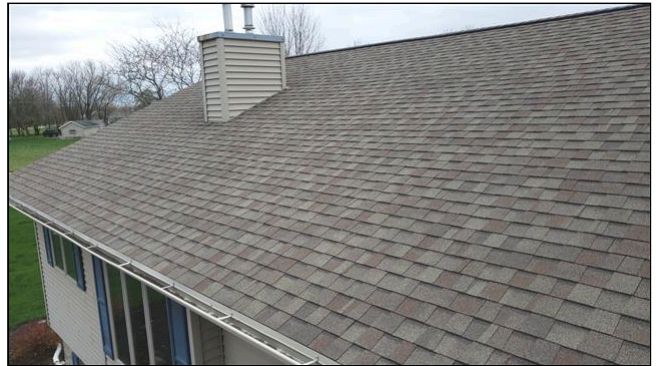
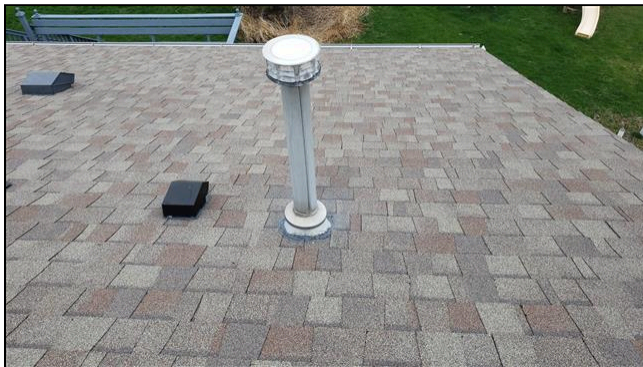
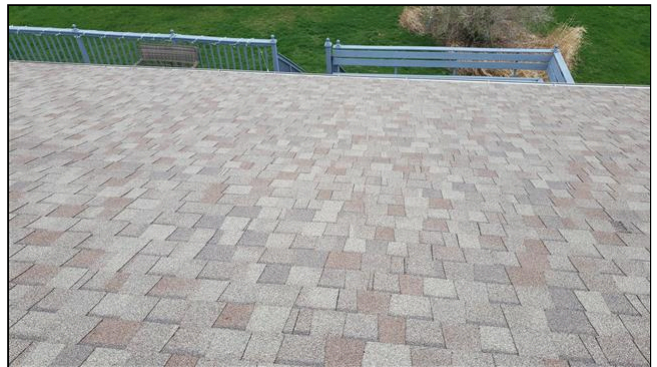
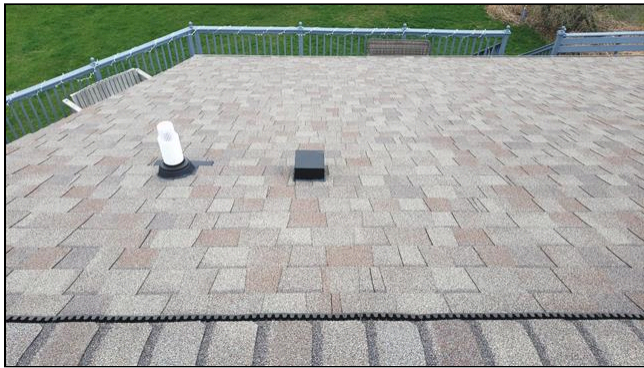
(1) Roof views

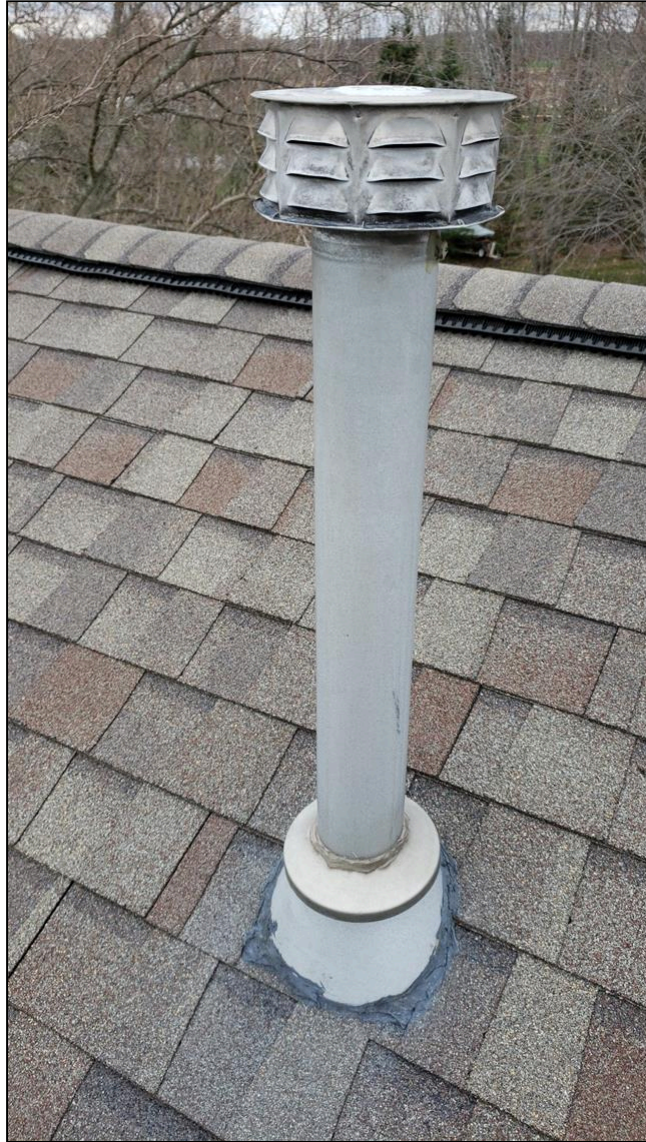
1.2 Item 2(Picture)

(2) Water heater vent

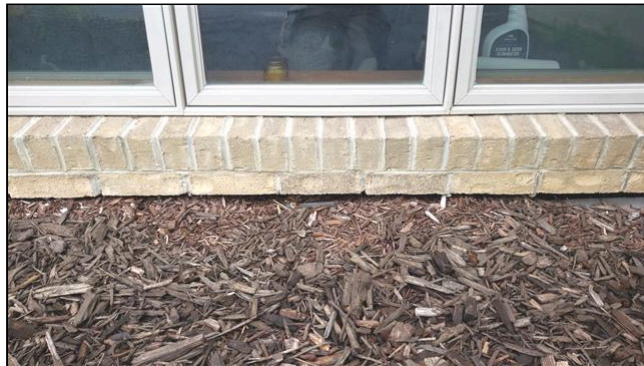
2.0 Item 1(Picture)

(1) Gaps under the windows to the brick sills should be sealed.

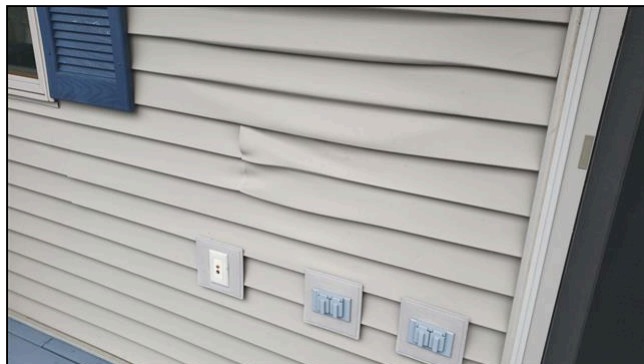
2.0 Item 2(Picture)

(2) Buckled siding due to the grill to close at the rear.

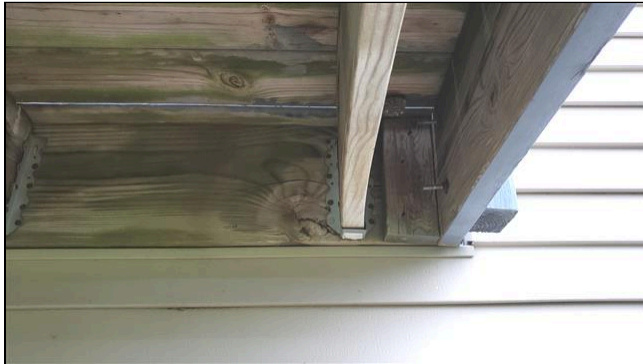
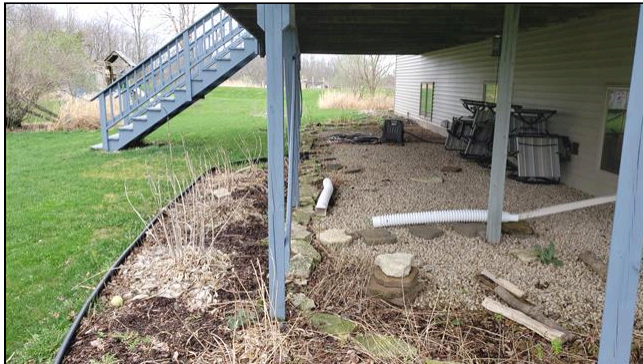
There is a bit of sag in the footings for the columns and some columns are out of plumb.

The combination railing and seat at the north end is less than safe and could ne better secured.

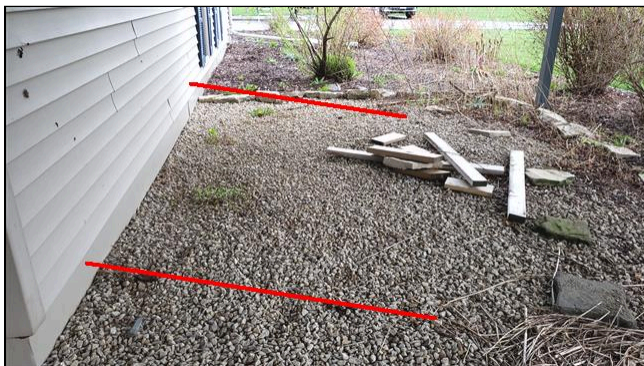
2.5 Item 3(Picture)

(3) Negative grading at the foundation is apparent in many areas around the foundation. This can cause significant damage to the foundation. The grading at the foundation should slope down and away from the foundation at at least an inch per foot out 4' or better or to a point at which the water can keep flowing away. Best practice is to then cover the dirt with heavy mil plastic sheeting tucked up under the siding starter strip, then some sort of landscape material, fist size (3") round river rock works best. THEN NO EDGING!

With that done, after one good dry summer, the back fill will dry so much that it will shrink and take pressure off the foundation wall and stop any moisture from permeating through the wall, drying off into the bsmt as water vapor, that would have to be removed by a dehumidifier.

Grading at the foundation should be looked at as a preservation related improvement to protect the foundation.

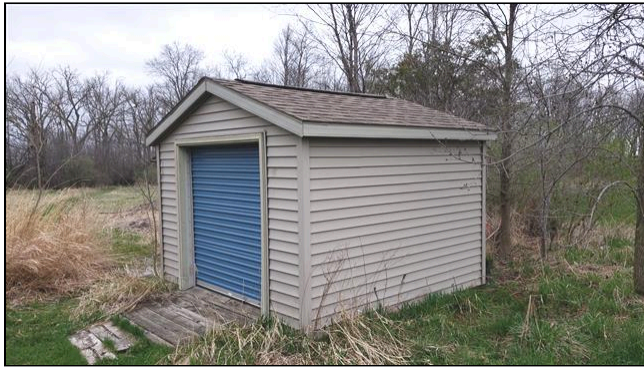
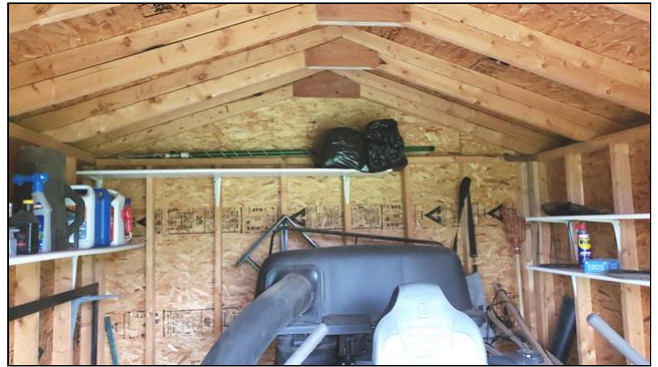
The shed is level and in good condition.

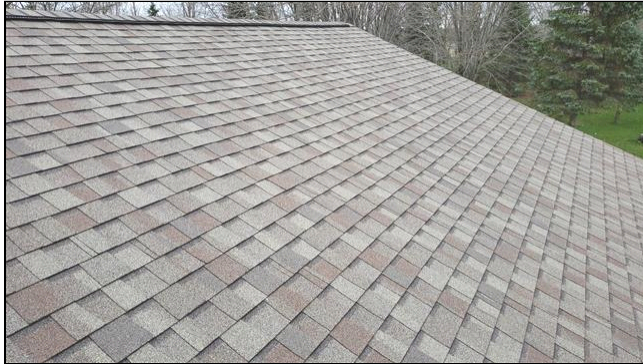
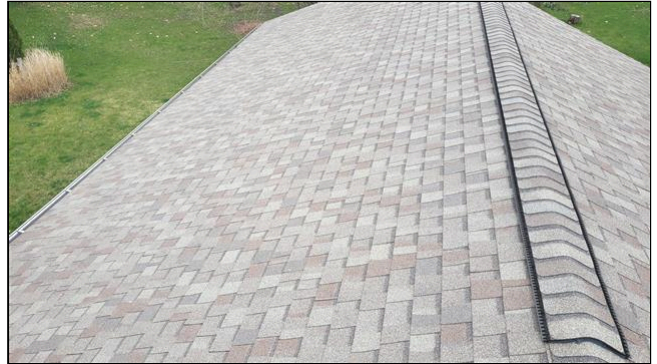
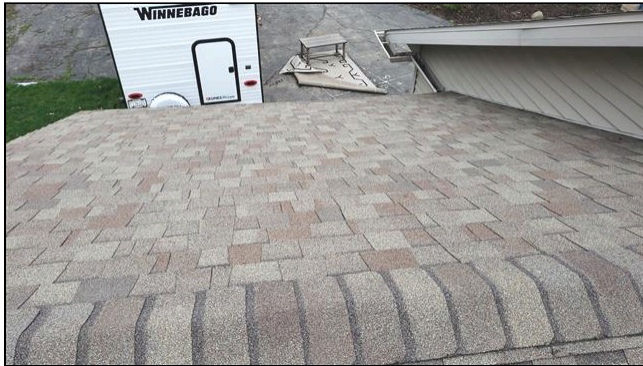
Same as the house

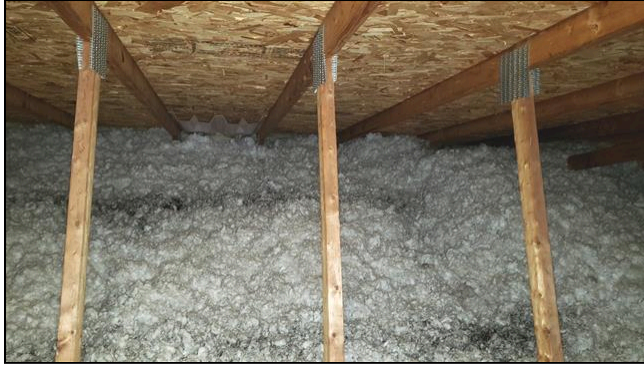
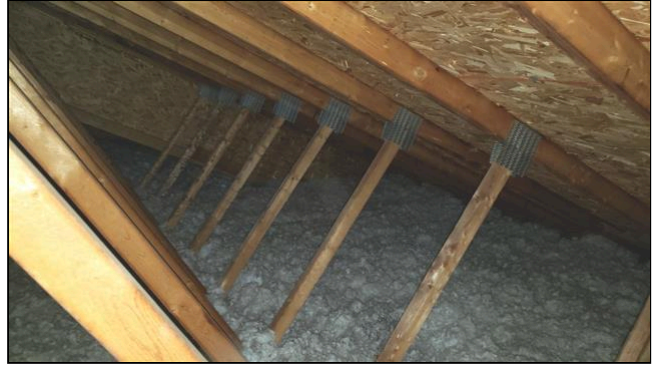
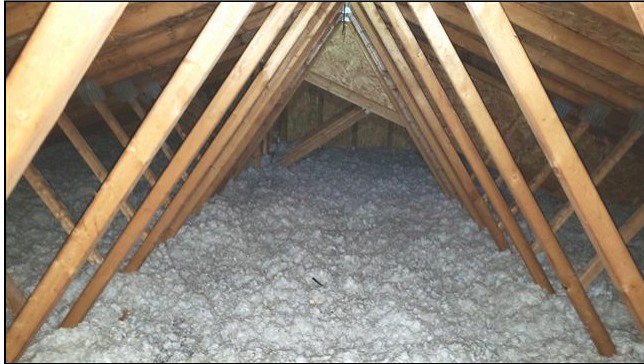
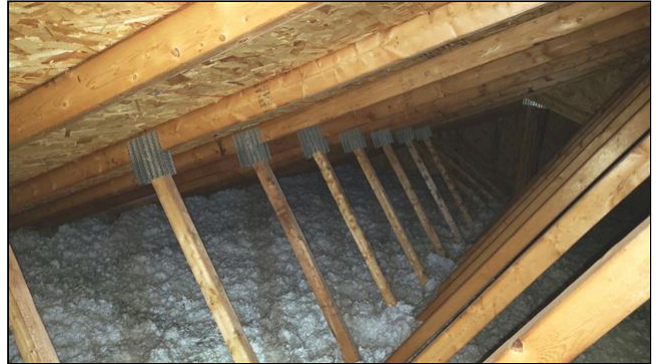
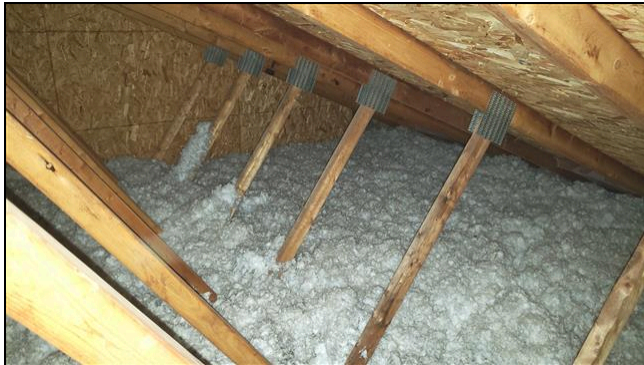
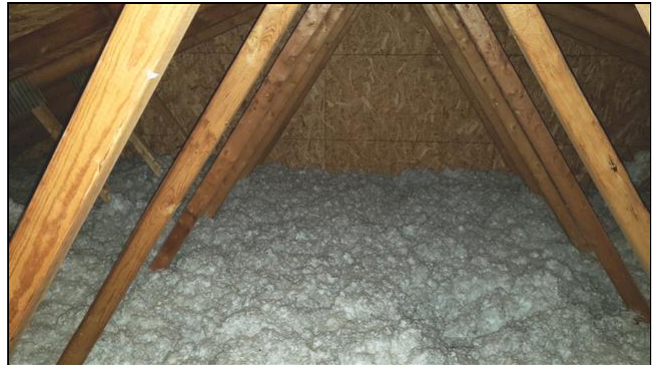
With insulated walls, attic and doors, you could keep the garage above freezing for the winter just with the heat off the cars everyday.

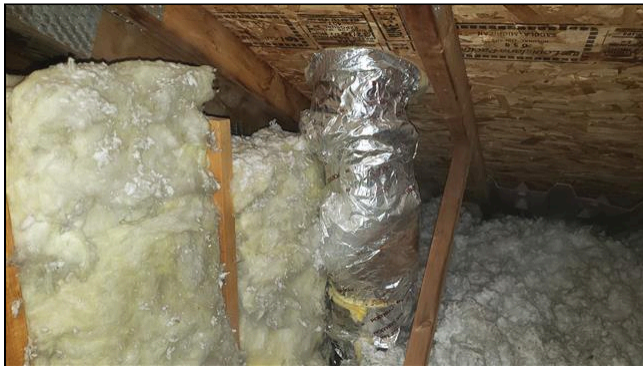
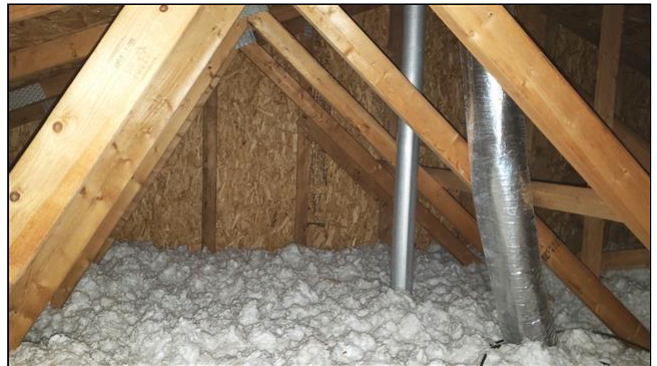
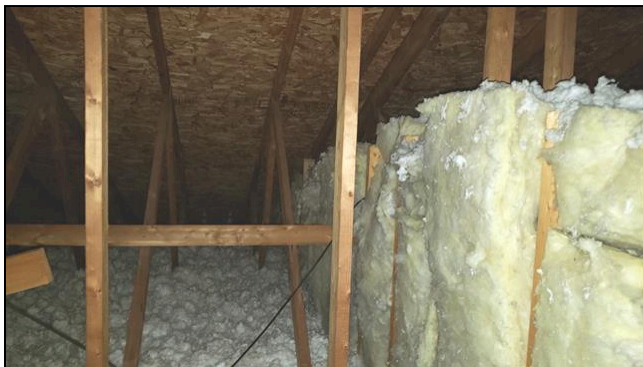
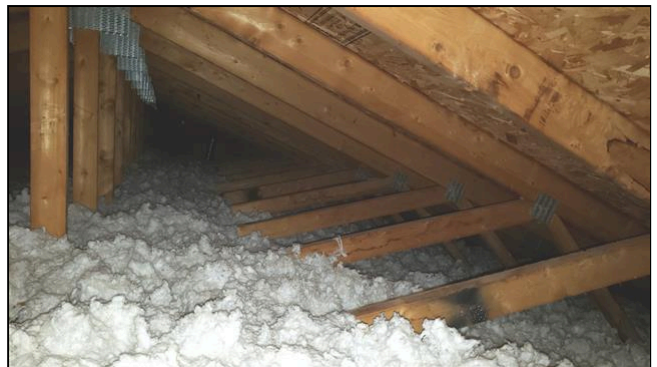
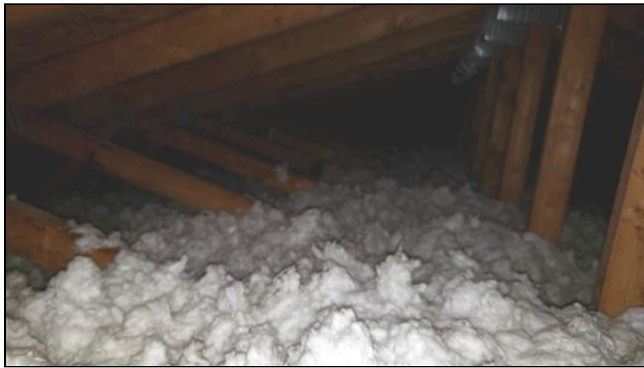
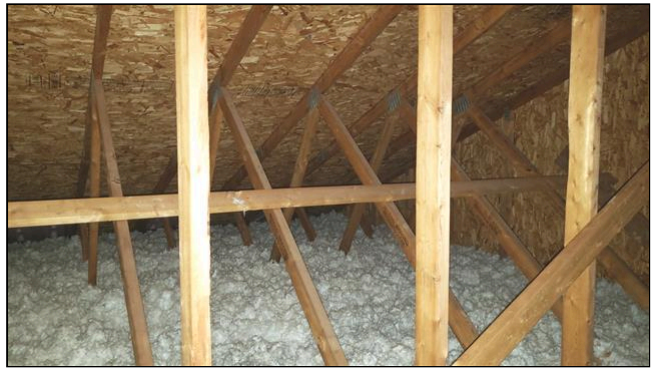
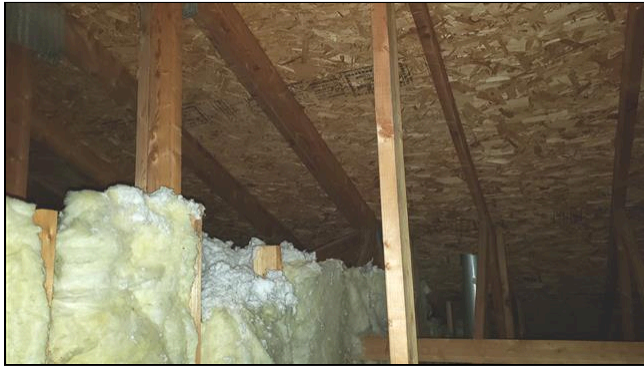
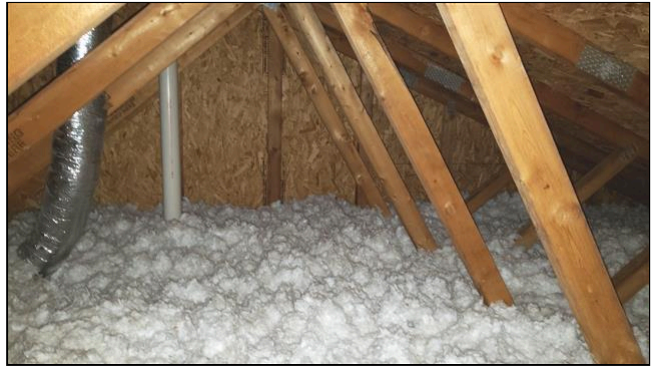
(1) Attic views

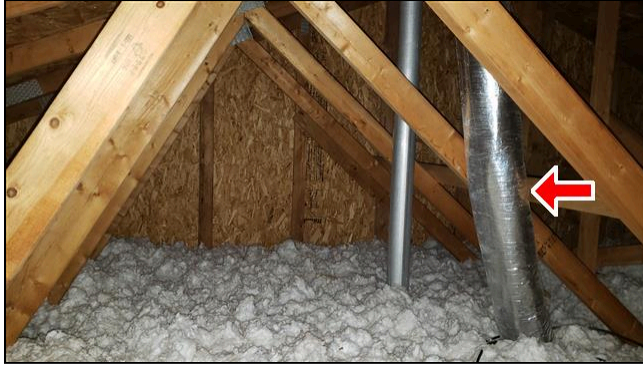
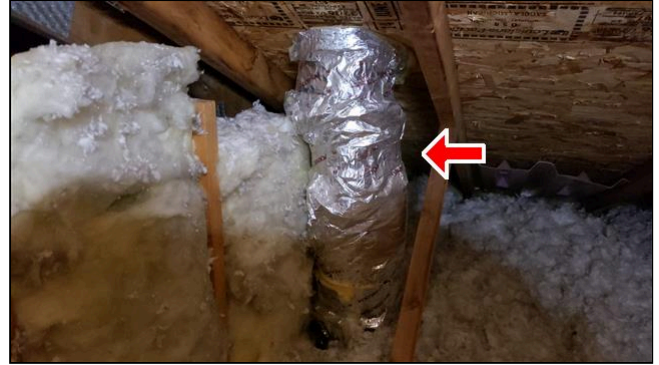
Outstanding, the bath exhaust is ducted through the roof in insulated ducting as is the kitchen exhaust.

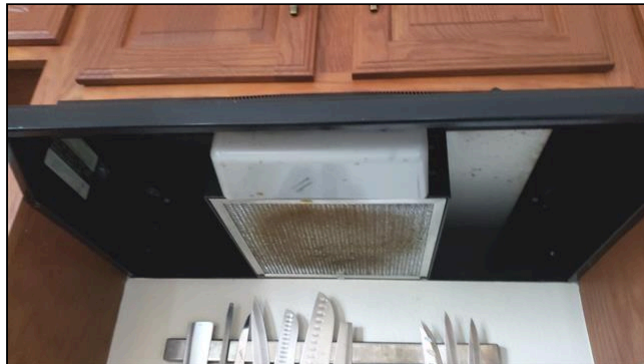
6.2 Item 1(Picture)

The kitchen exhaust was quite loud possibly or partially due to the plugged filter.

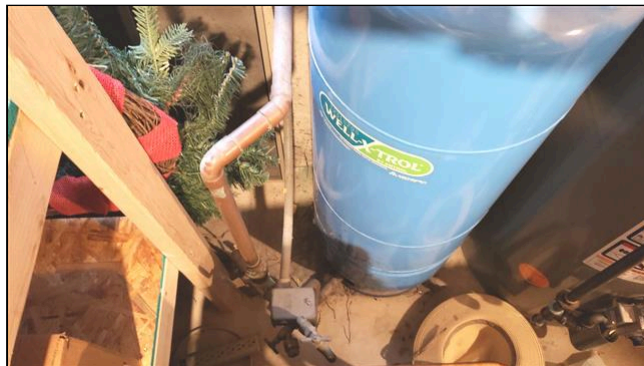
8.0 Item 1(Picture)

At the tank and in the service panel

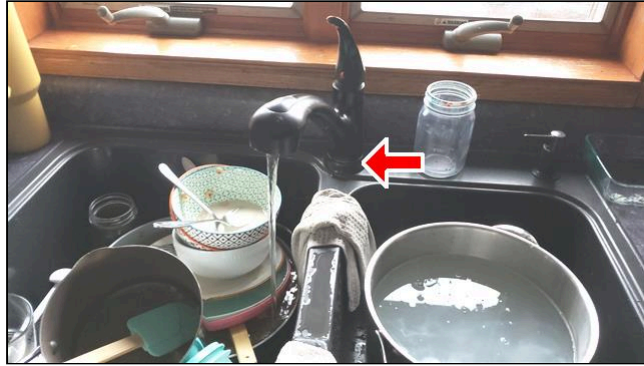
8.1 Item 1(Picture)

The kitchen faucet will not pivot.

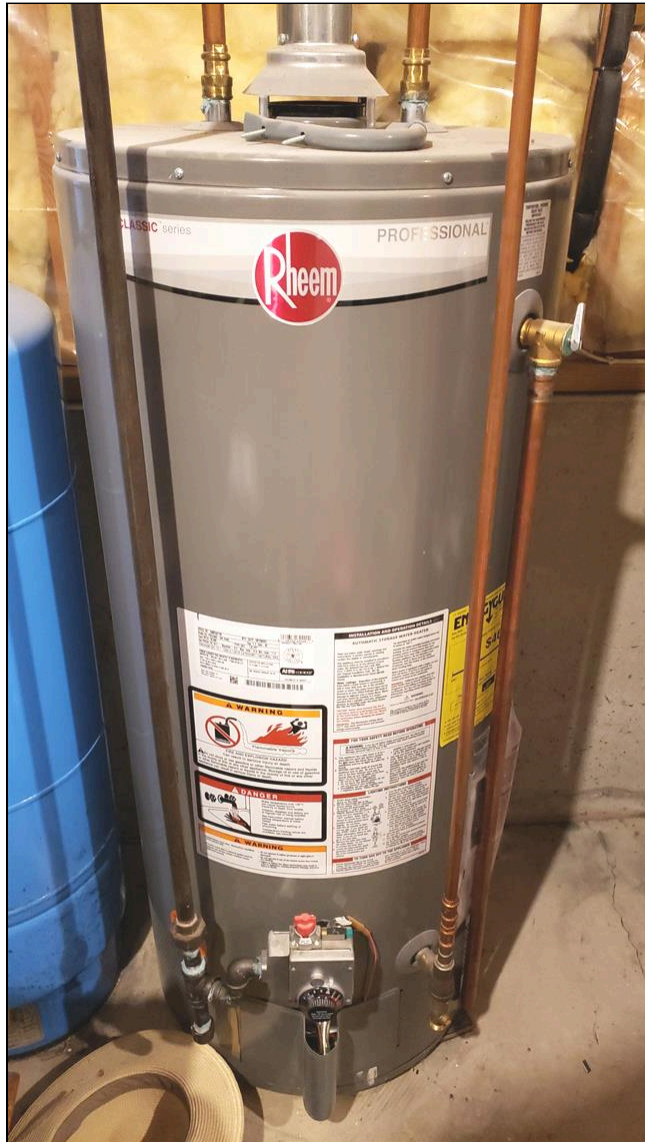
Water heater

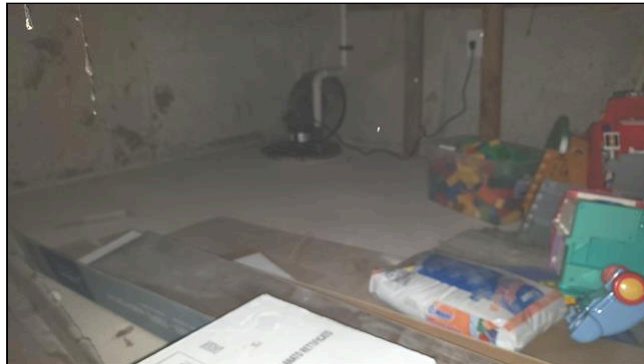
8.7 Item 1(Picture)

What ever the radon comes in at , can be drastically reduced by replacing the pedestal sump pump with a submersible and sealing the pit.

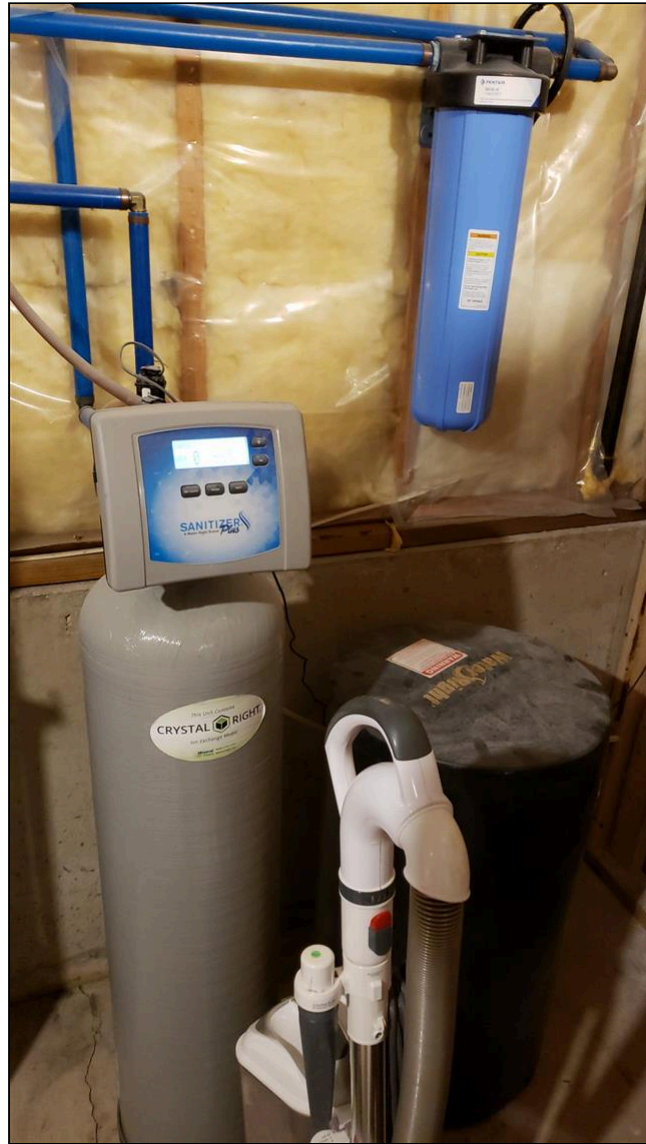
8.8 Item 1(Picture)

Not inspected

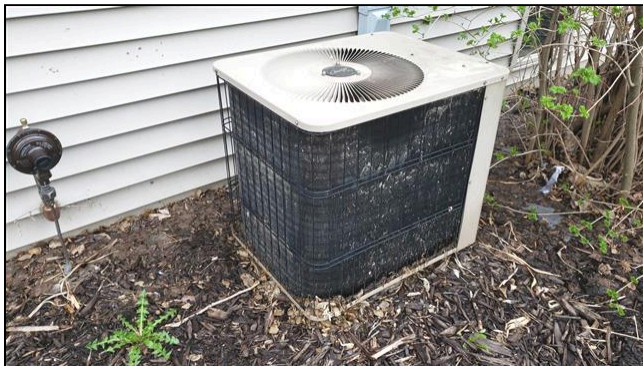
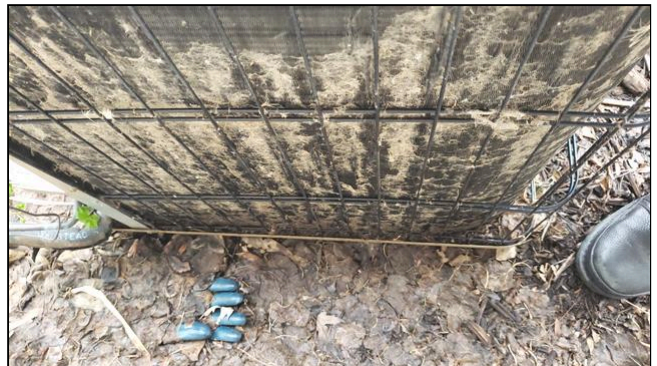
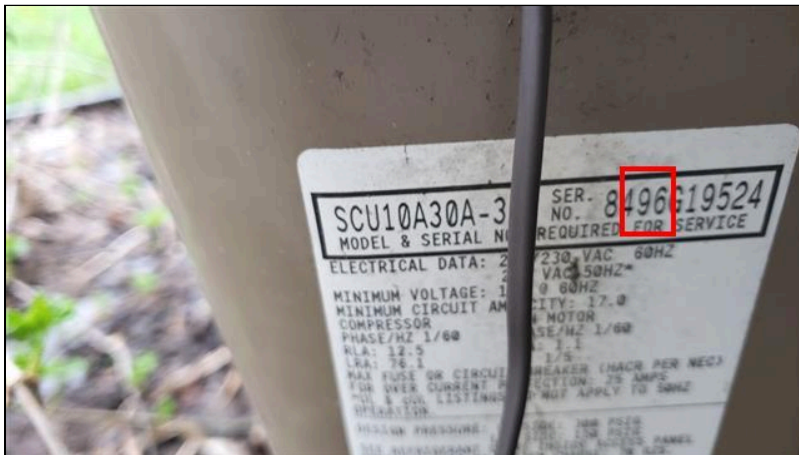
(1) The A/C was not tested for proper operation due to the outside air temperature being less than 65 degrees.

(2) The compressor/condenser at the exterior should be maintained in a level position and the use of winter covers is not recommended.

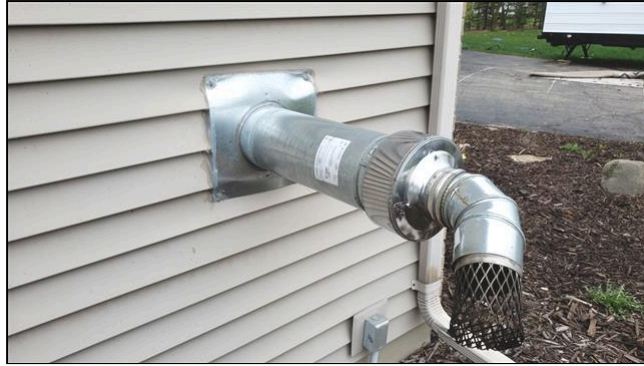
10.8 Item 1(Picture)

📌 The pellet stove has not been cleaned for some time and the poor flashing at the exterior of the vent piping points to less than professional installation.
